# Point Peron "K" Battery Conservation Management Plan

South West Corridor Development Foundation Inc.

March 2016

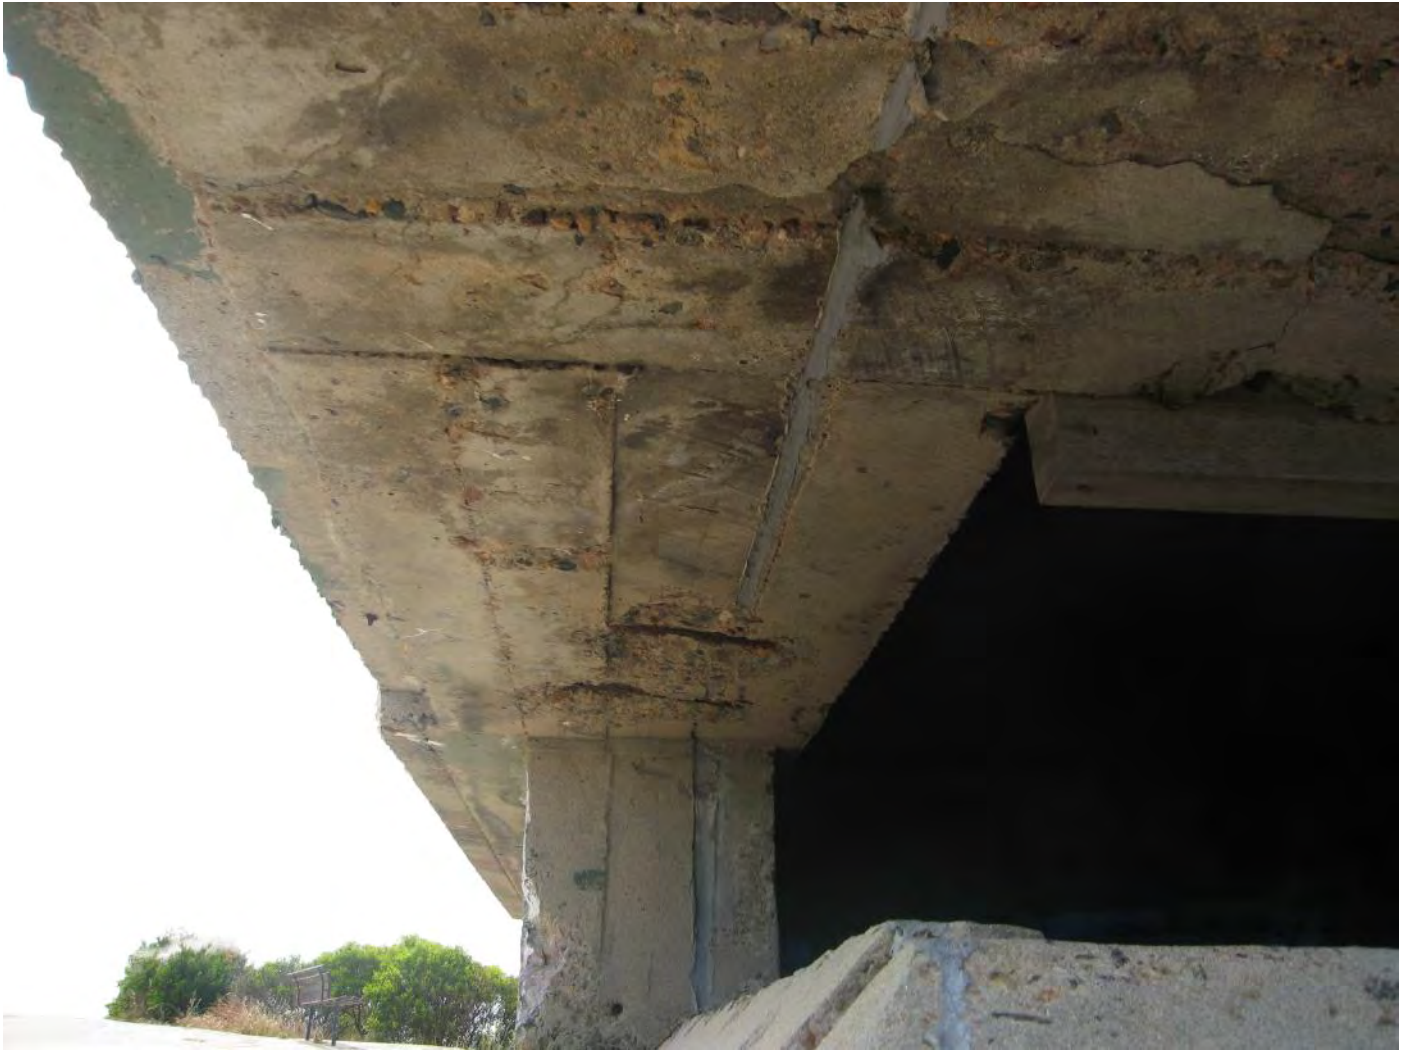
Research has shown that in similar structures, the ground level often came up to the bottom of these projection or slightly above providing support. Over time the ground level has eroded or has been manually removed to provide a flat walking surface around the structure which has removed all support for the projecting element. As a consequence, the weight of the projecting storage area is pulling the wall away from the rest of the structure which is evident in the cracking seen along the brick joints.

**Figure 61:**      **Underside of Concrete Overhang to Observation Opening**

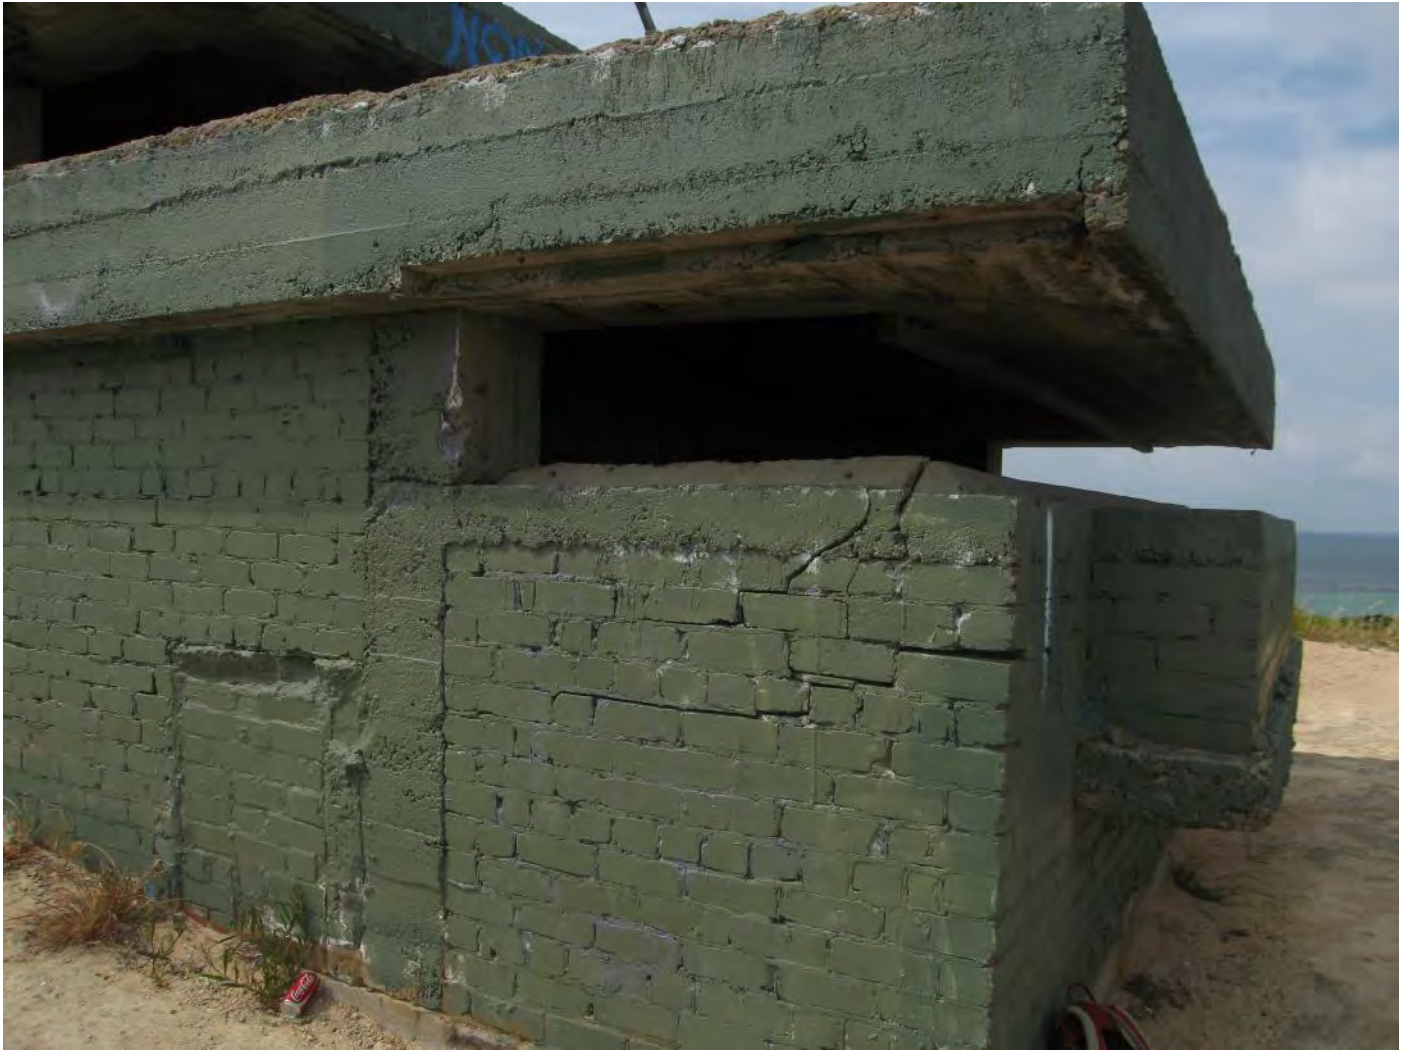
**Figure 63:** North Elevation – western corner being pulled away from the main elevation

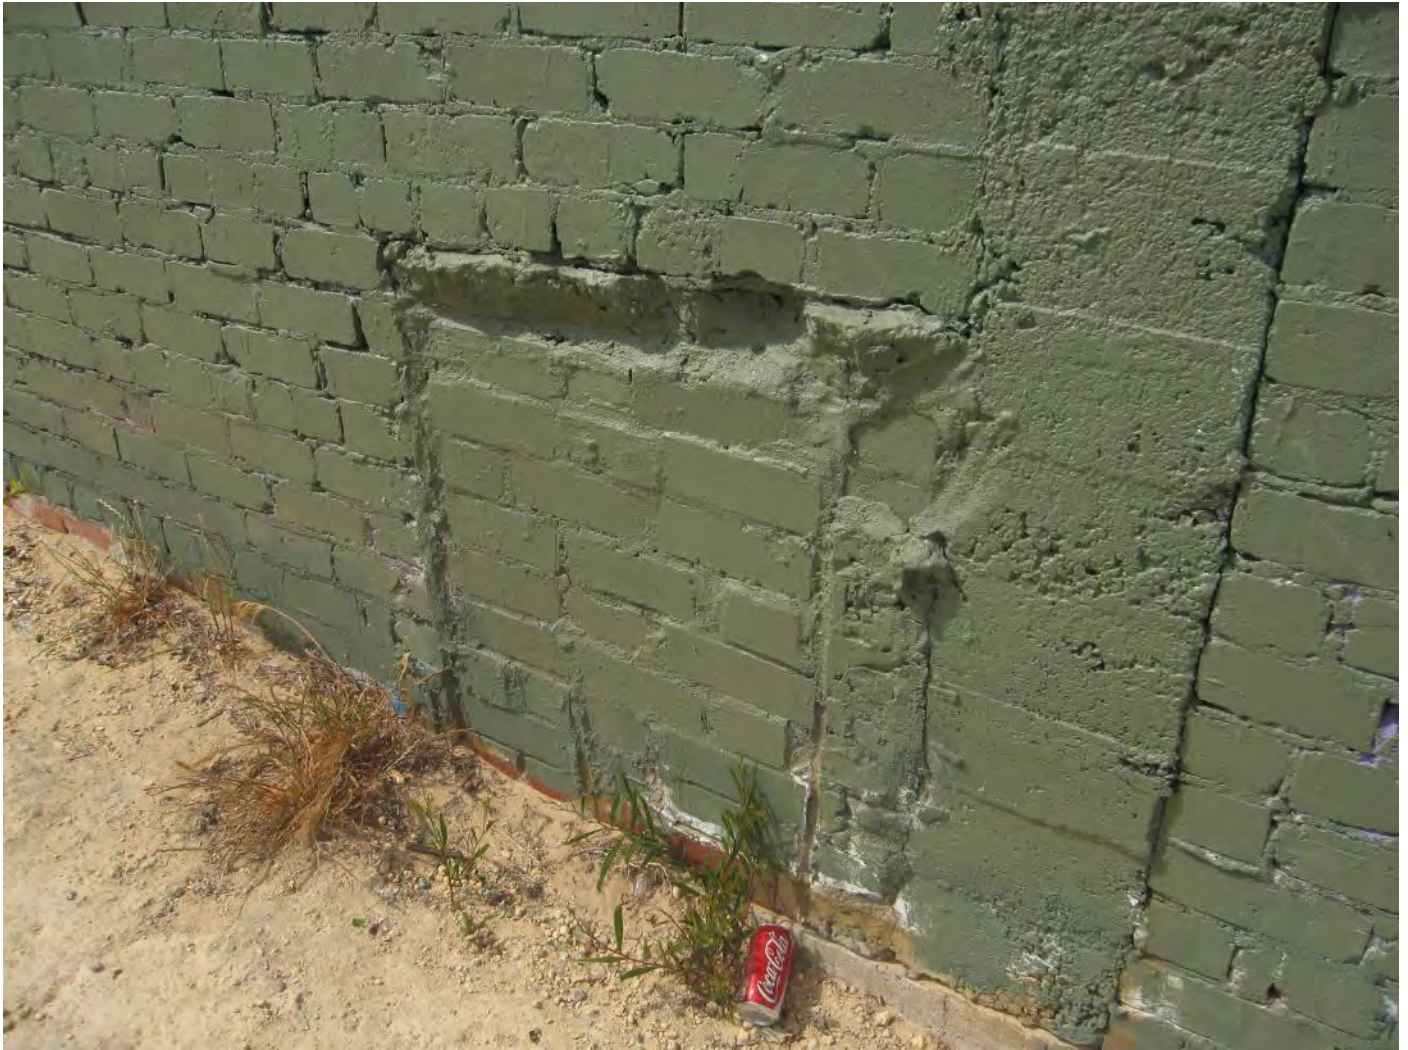
The construction method of the structure is very basic, possibly reflective of the required haste in erecting these buildings. The basic form of the building comprises the reinforced concrete framework with the brick infill panels. The weakness being that the brick sections are not keyed into the concrete frame. Concrete slab top layers to the brick walls around the embrasure opening provide some structural strength but as the image above demonstrates, the weight of the projecting storage section to the west elevation is pulling the brickwork away and has caused cracking in the concrete top layer around the opening.

Figure 64: North Elevation – brick infill panel

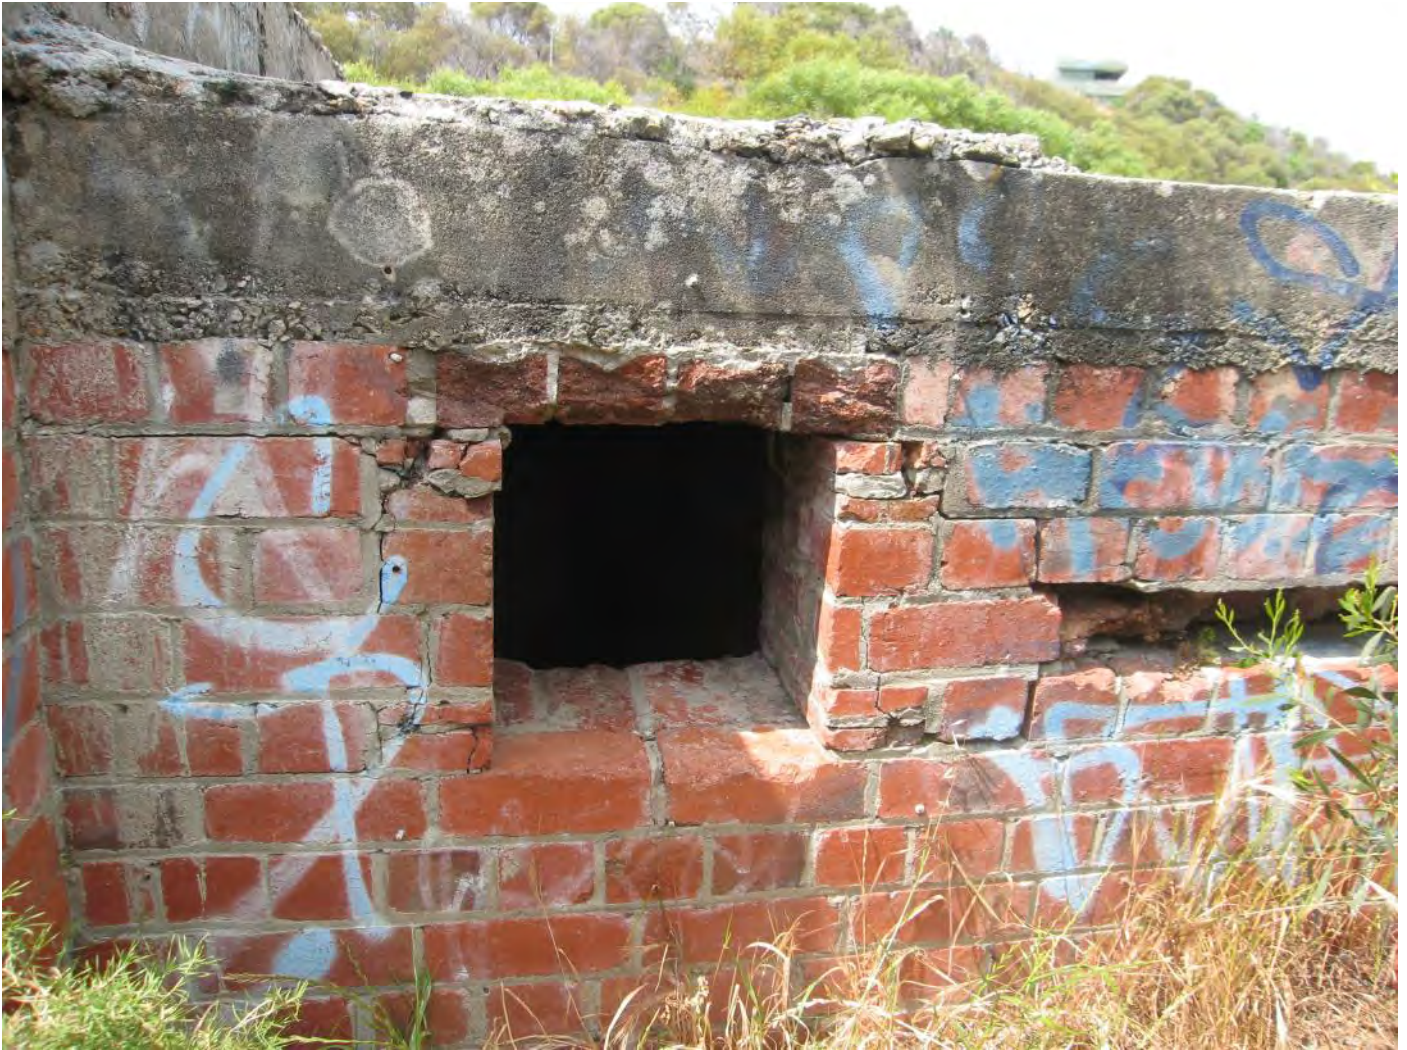
The west elevation is largely submerged in the sand dune but the top ten brick courses are visible with an extensive crack extending along the full extent of the elevation, following the mortar joints. The crack is caused by the failure of the steel bar reinforcement in the brickwork which has rusted and expanded causing the brickwork to move and become loose. Brick from the north west corner are missing which will contribute to the continued deterioration of the brickwork and enlargement of the crack.

**Figure 85:** Operations Bunker – Openings in north wall

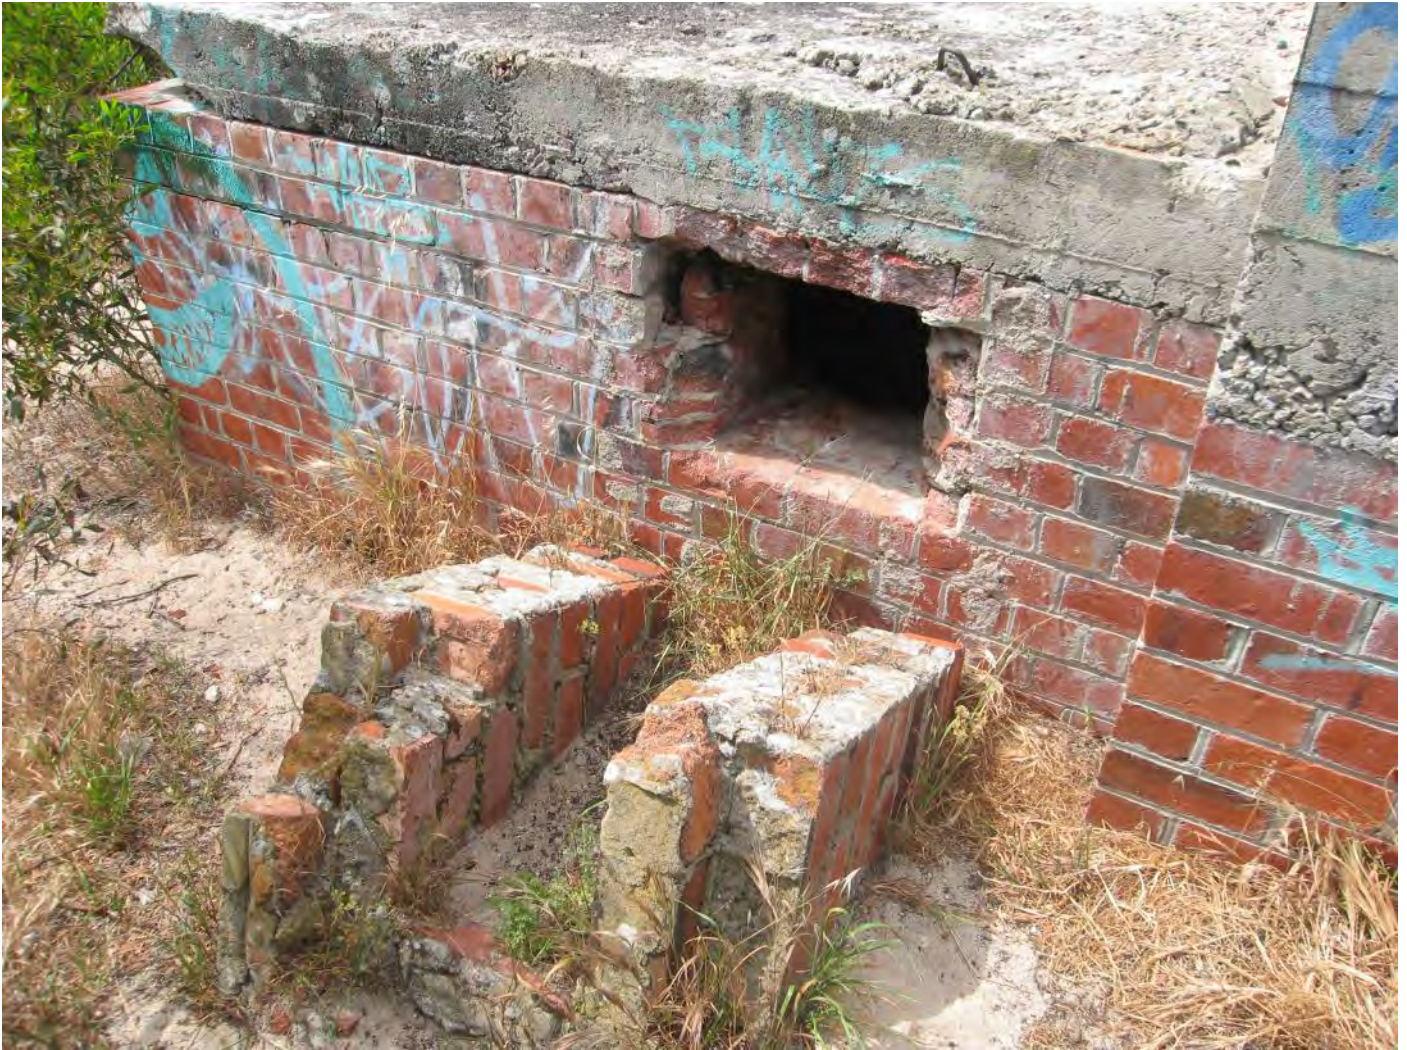
The brickwork immediately to the west of the opening, closest to the west elevation, is deteriorating. Bricks are missing with much of the damage being caused by the rusting and failing reinforcing steel. Previous repairs have been carried out with some evidence of localised repointing.

**Figure 86:** Operations Bunker – Openings in north elevation and remnant fabric

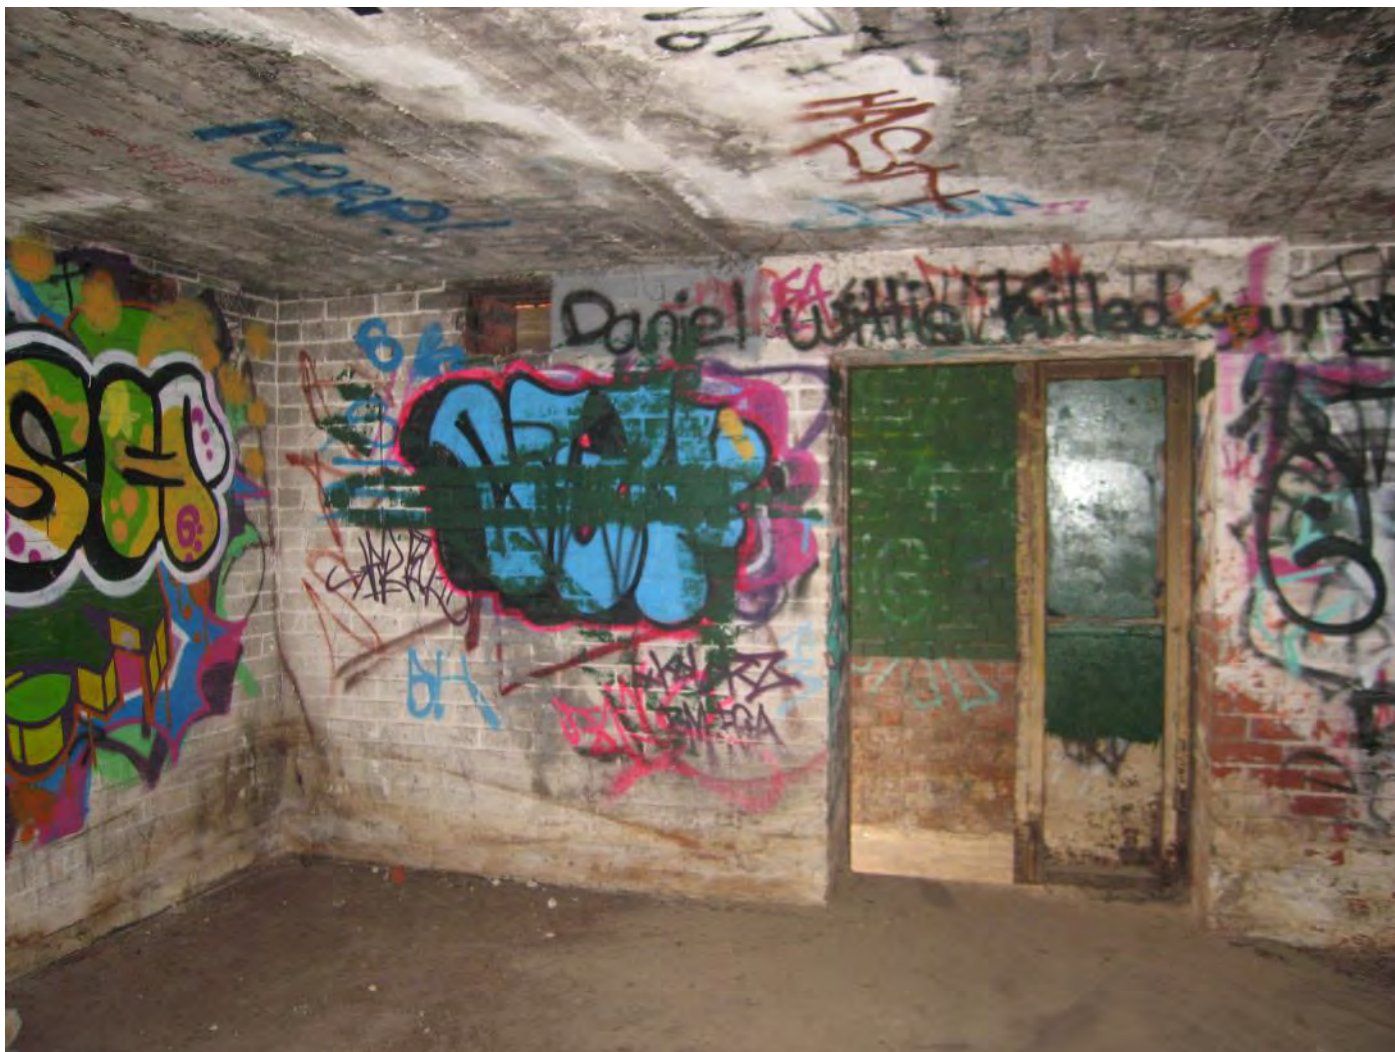
Loose bricks have collected on the concrete slab floor from the north west opening.

Figure 91: Operations Bunker – Interior (south wall)

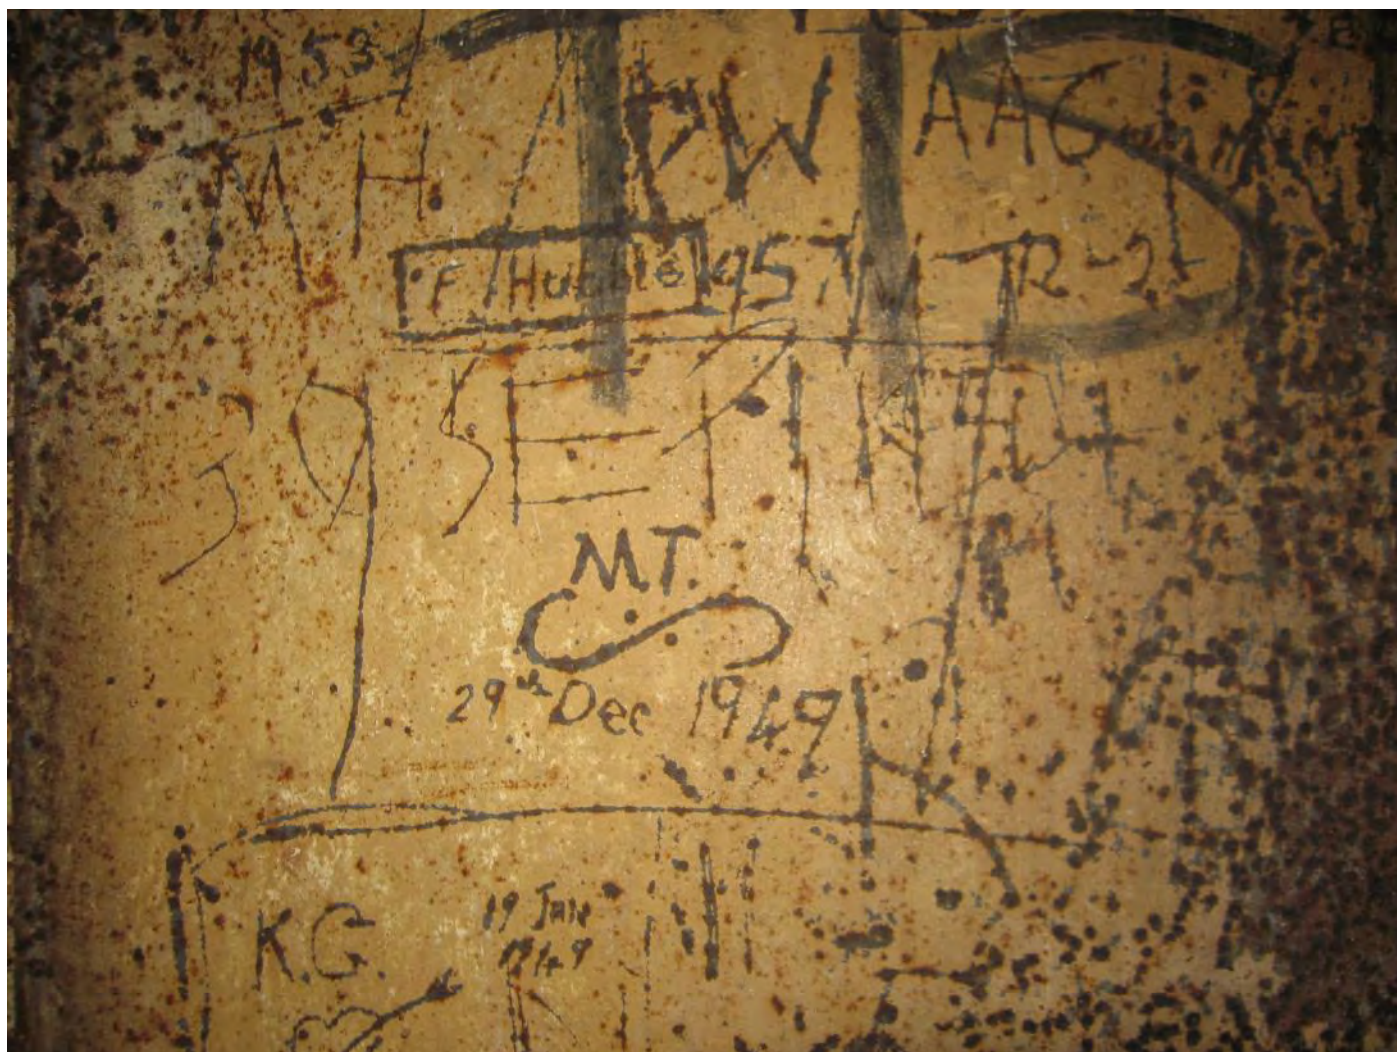
Figure 95: Operations Bunker – Graffiti scratched into entrance doors

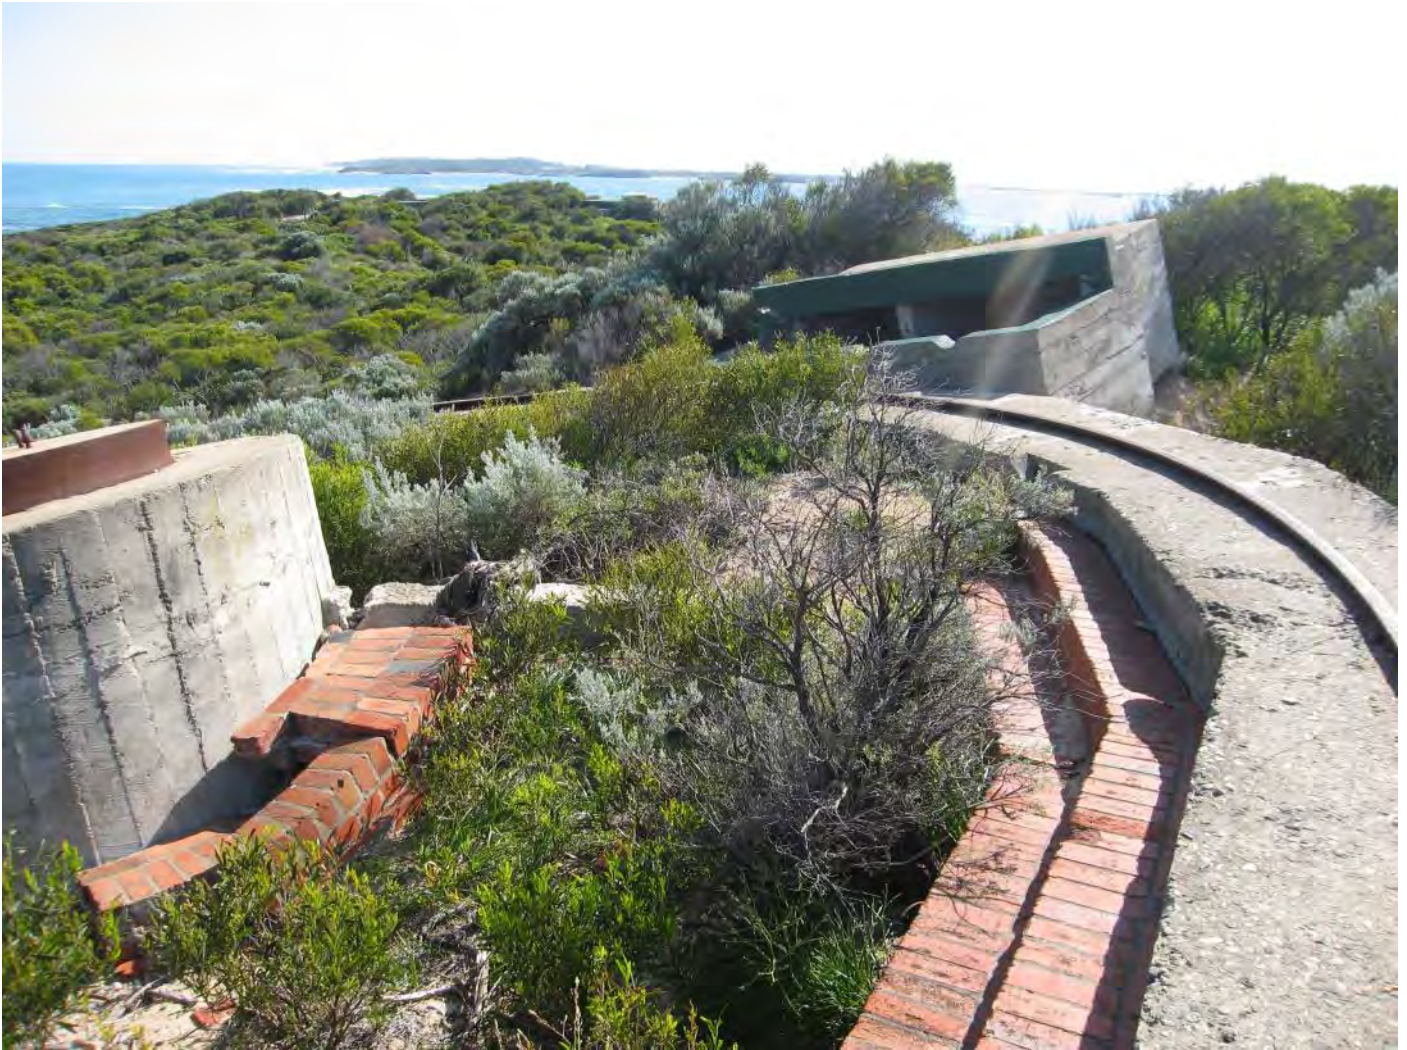
**Figure 98:**      **Gun Emplacement**

Gun Emplacement No. 1 is not in a good condition, clearly demonstrating how the instable land formation has impacted on the structural stability of the gun emplacement. Over time, the ground levels have changed with much of the sand being eroded revealing the structure of the gun emplacement and eventually undermining its stability as the land has moved away. Much of the original fabric remains in and around the structure but a full understanding of the planning of the gun emplacement and its related structures and functions is no longer clearly visible.

- Policy 6.17 Gun Emplacement No. 1 is in poor condition due to the instability of the underlying ground conditions. The Gun Emplacement has slipped and is no longer in its original form or position. It is not recommended that this feature be reconstructed as its current condition contributes to the story of the site. However, visitor safety and structural stability is essential and works are required to stabilise the structure before it slips any further. Stabilisation works are to be undertaken to the engineer's and heritage architect's specifications.*

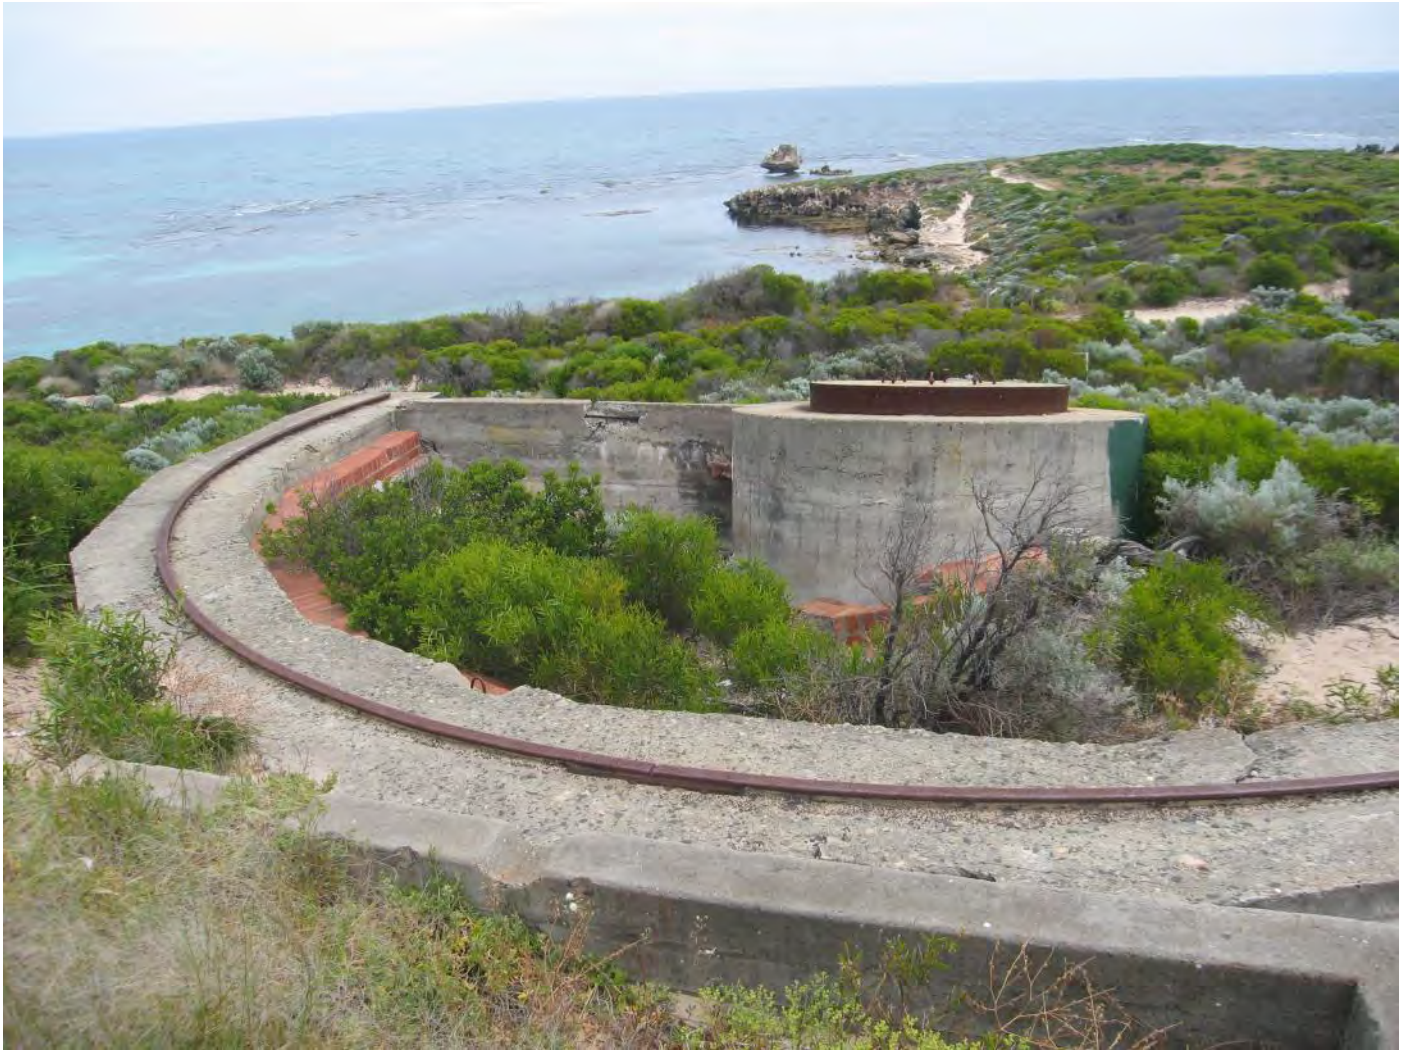
**Figure 99:**      **Gun Emplacement**

Brick steps extend around the internal side of the concrete structure, leading to a brick paved floor and to the central gun mount. The brick elements have become displaced and no longer full extend around the internal space of the gun emplacement. Sand has accumulated and bushes grown in the internal area, further obscuring the planning of the gun emplacement.

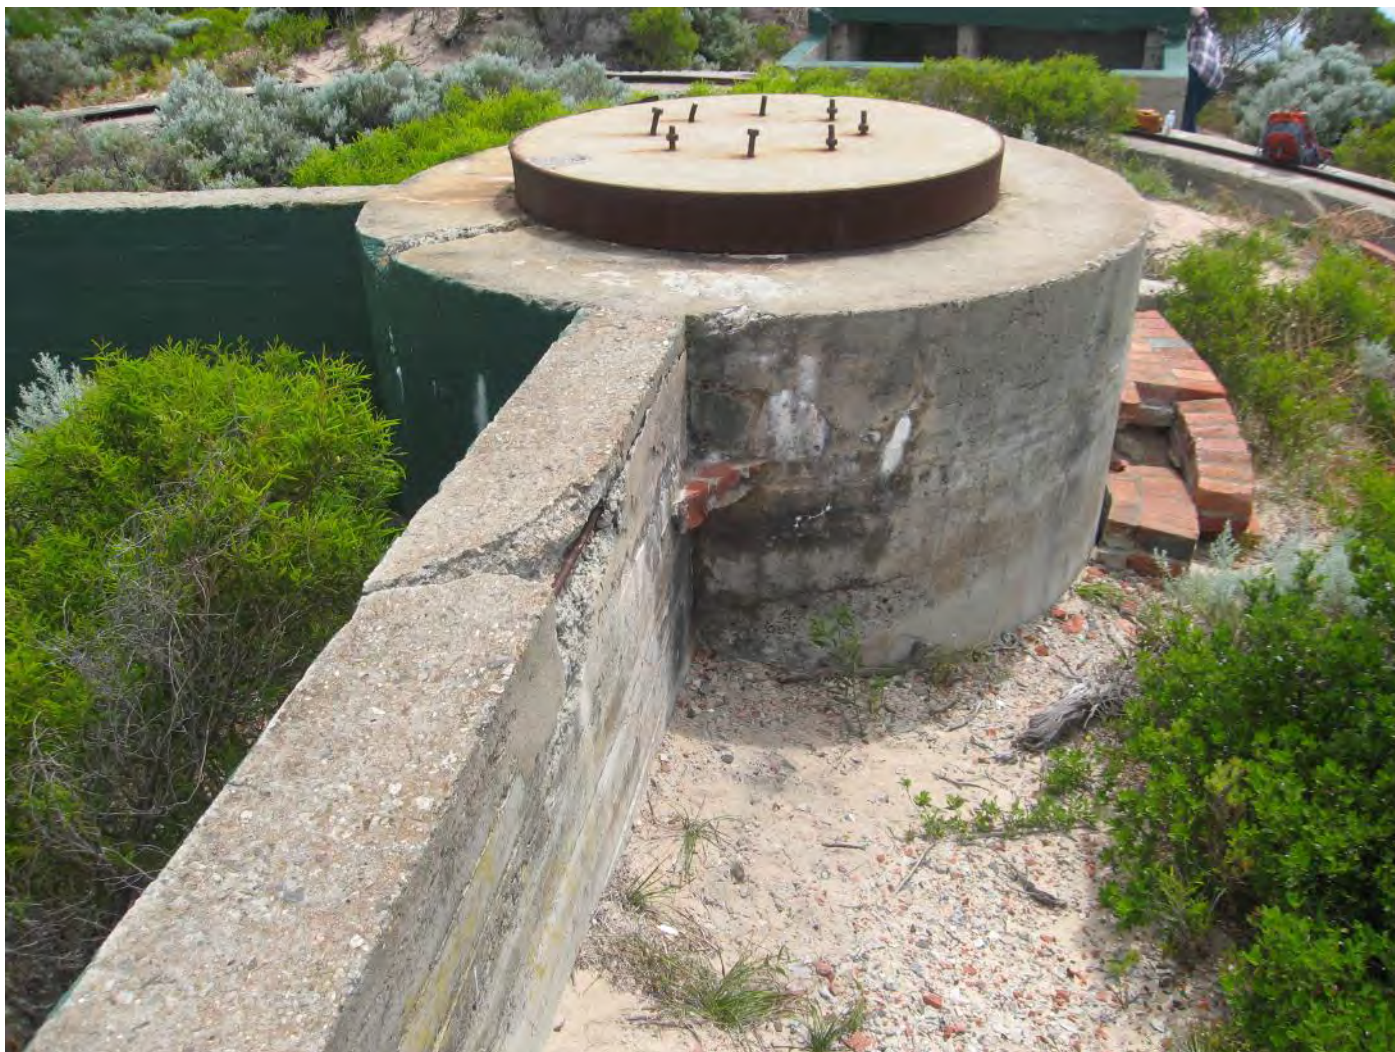
Figure 101: Gun Emplacement - rusted steel reinforcements causing chunks of concrete to blow and break off

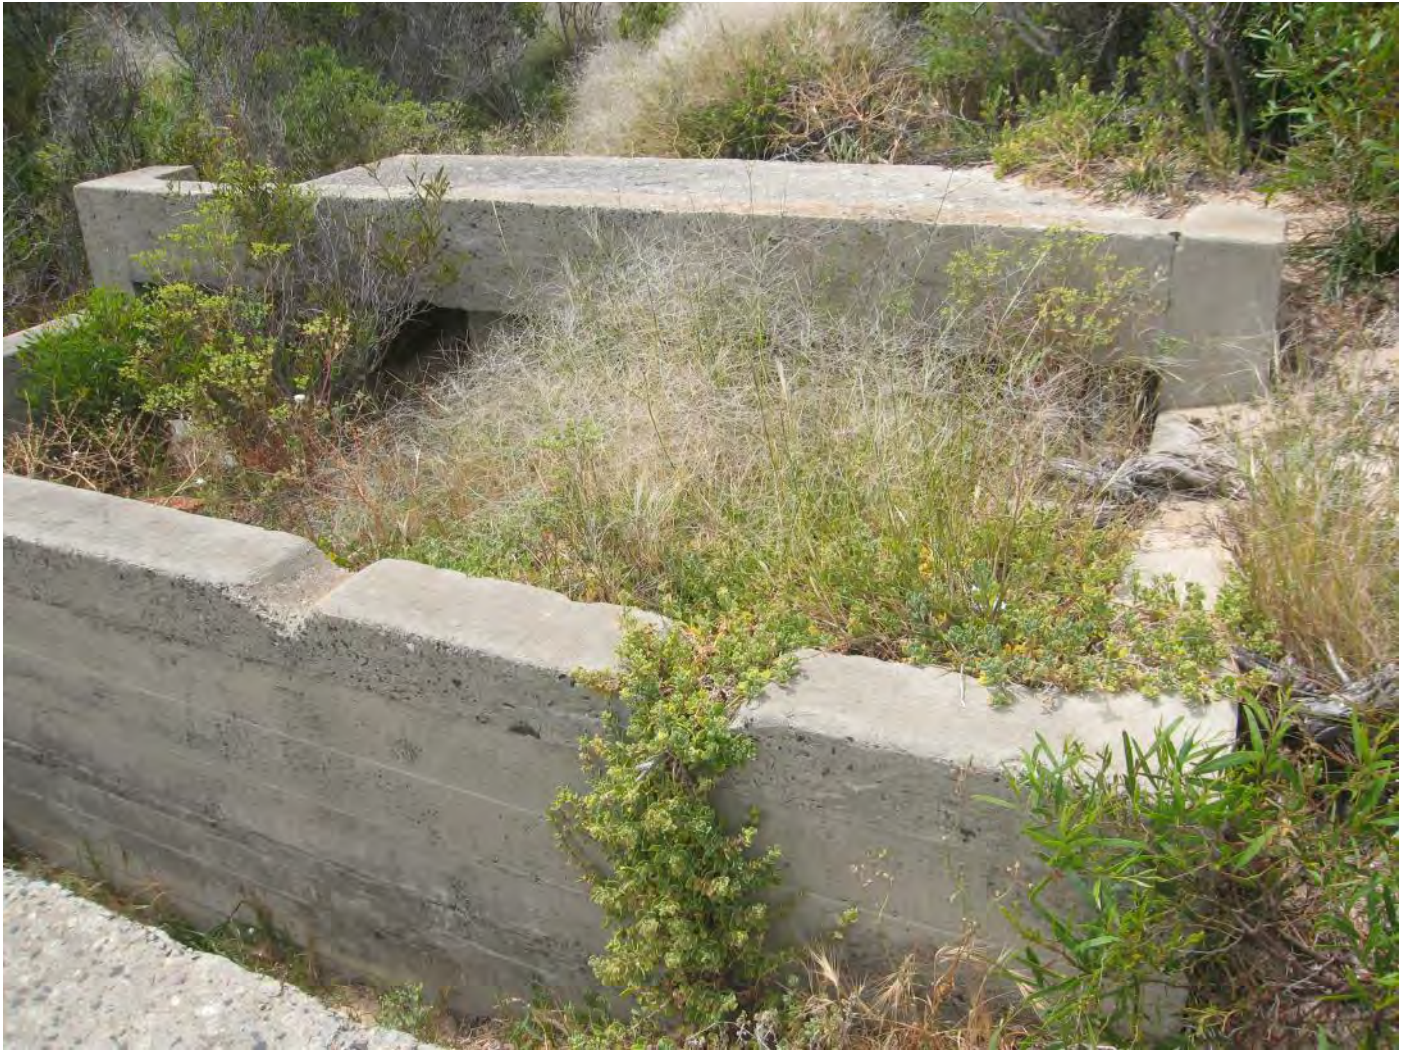
Figure 112: Gun Emplacement - Ammunition Store No. 2, sand in fill with vegetation growth

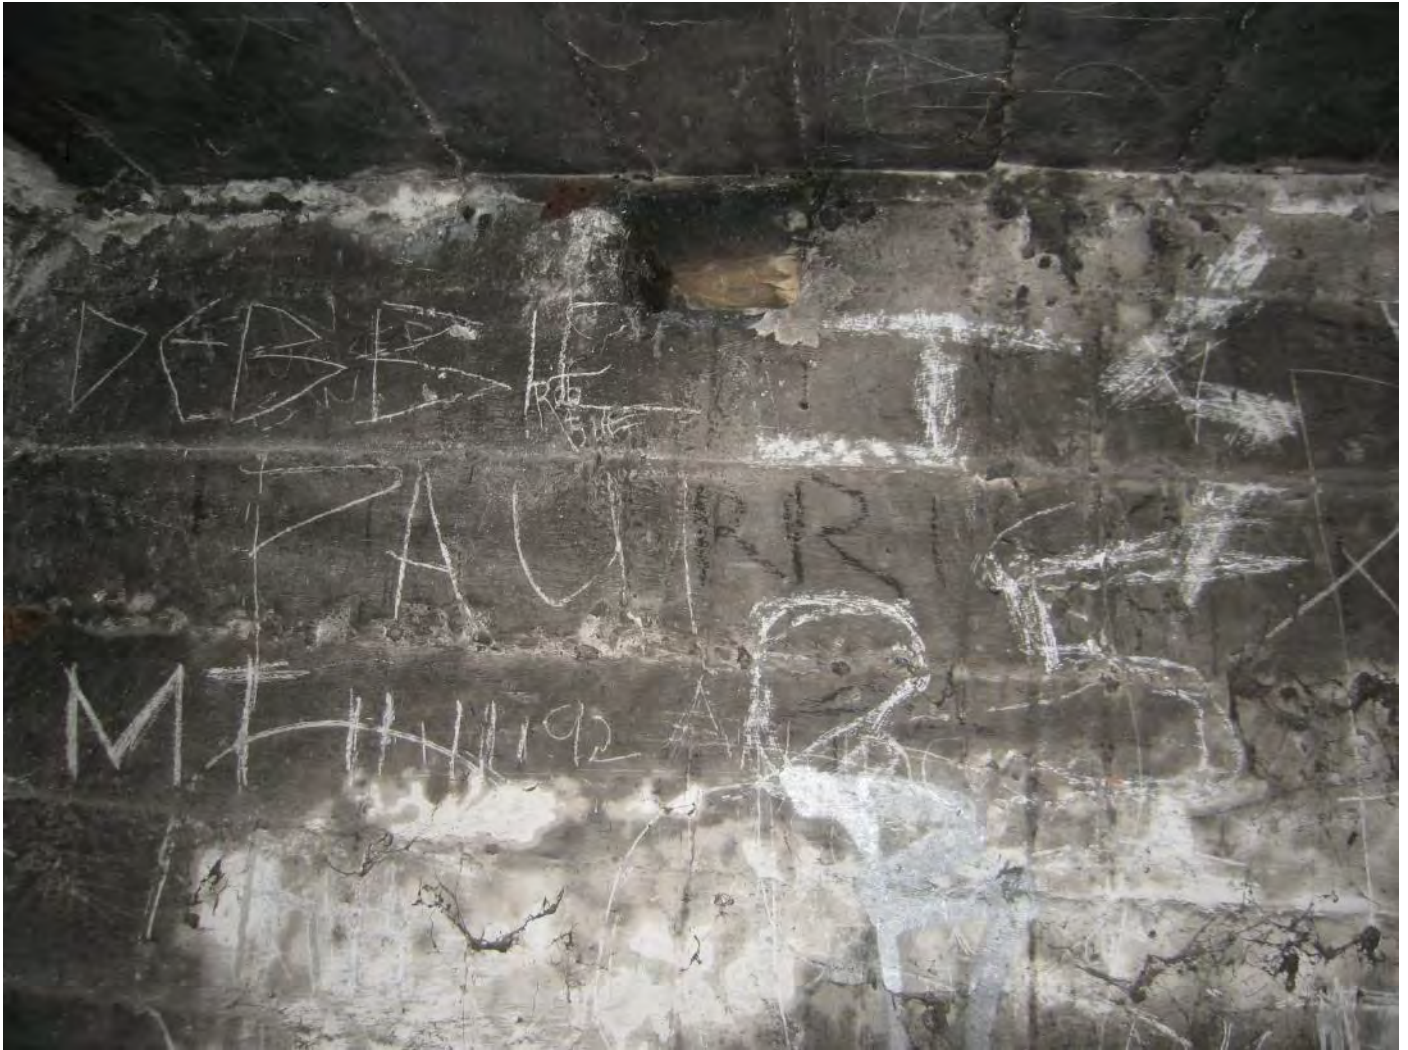
The walls are a dusty white with graffiti with damp staining and possible fire scorch marks.

Figure 123: Ammunition Bunker – graffiti in Room 1
