# Point Peron "K" Battery Conservation Management Plan

South West Corridor Development Foundation Inc.

March 2016

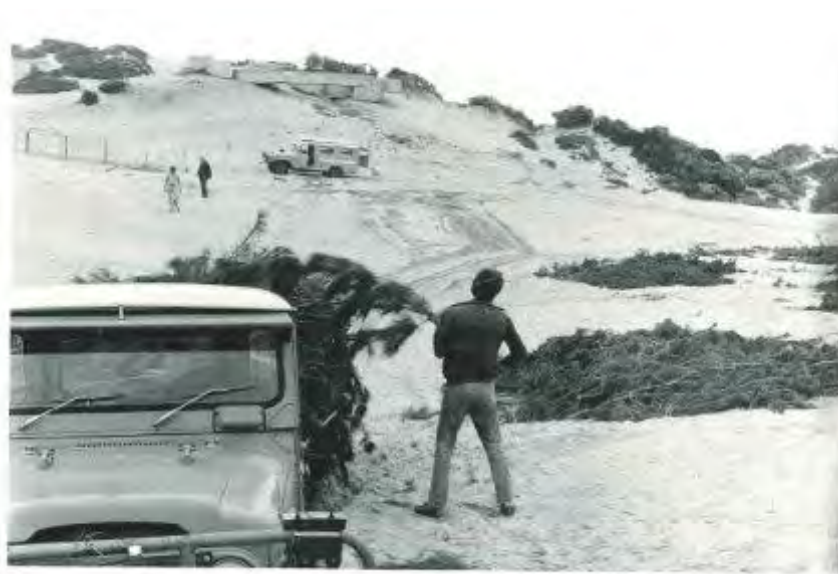
Figure 42: Conservation programs at Point Peron, c1980.  
Courtesy Tony Solin

The above image at Figure 42 shows how denuded the landscape was below the gun emplacement and is likely to have contributed to the destabilisation of the structure.

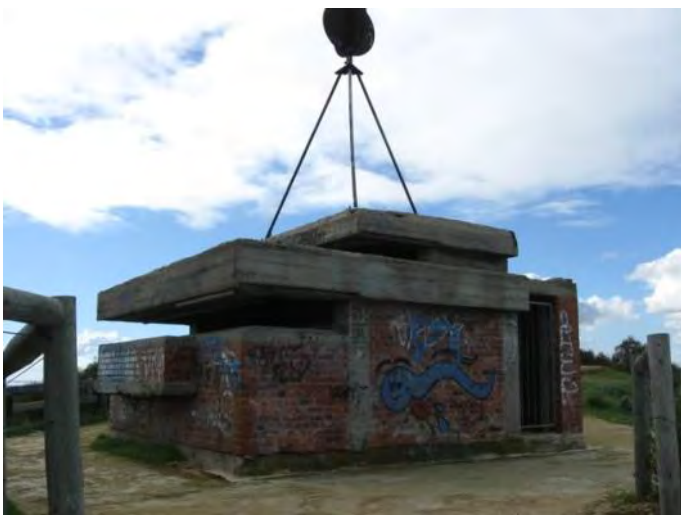
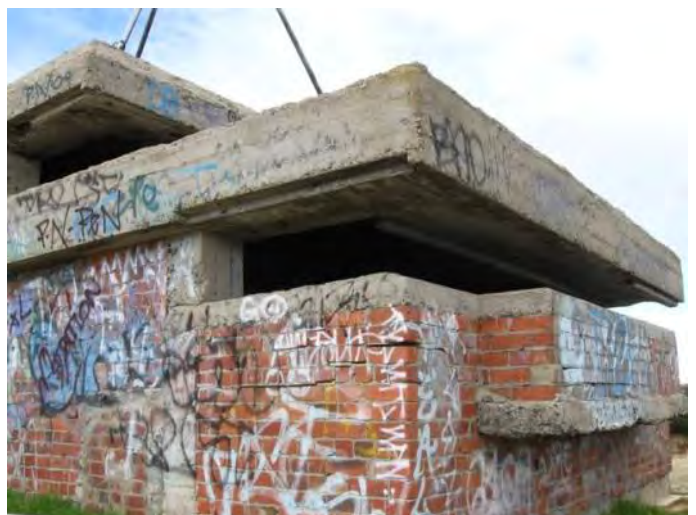
The Observation Post is essentially a simple square building with a flat roof of brick and concrete construction. Originally the structure presented in its more natural form of unpainted finish as illustrated in the photographs below but has been subjected to graffiti on a regular basis which was harming the brick and concrete finish and has since been painted to try and reduce the impacts of graffiti.

Figure 52: Observation Post before being painted, c.2009  
Courtesy: <http://perthurbex.livejournal.com/2393.html>

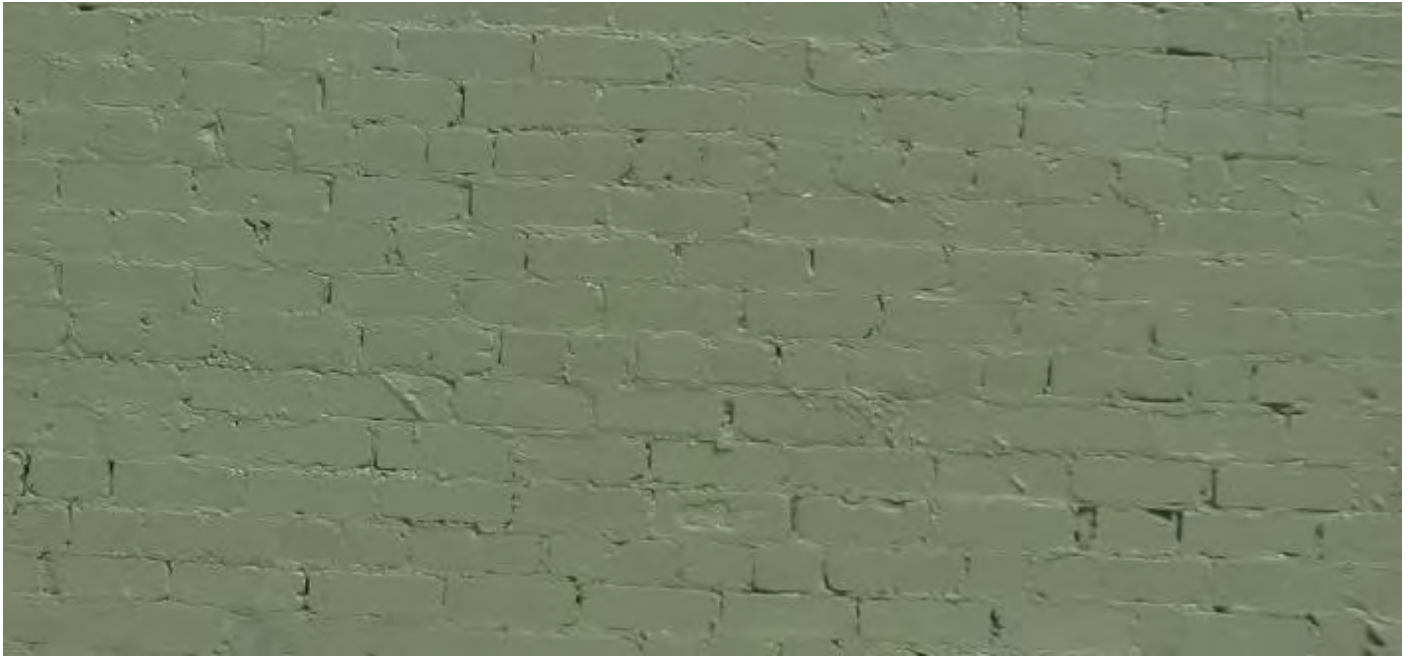
**Figure 55:** English Garden Bond Brickwork

The east elevation is the rear of the structure and presents with no activation. The elevation is stepped in terms of roof height with the lower section corresponding to the ground floor area of the structure and the higher level being the stairs to the upper section. The upper section of the east elevation has been rendered at an earlier stage, with the brick and mortar below this level being in variable condition. The reinforced concrete framework is also showing signs of deterioration.

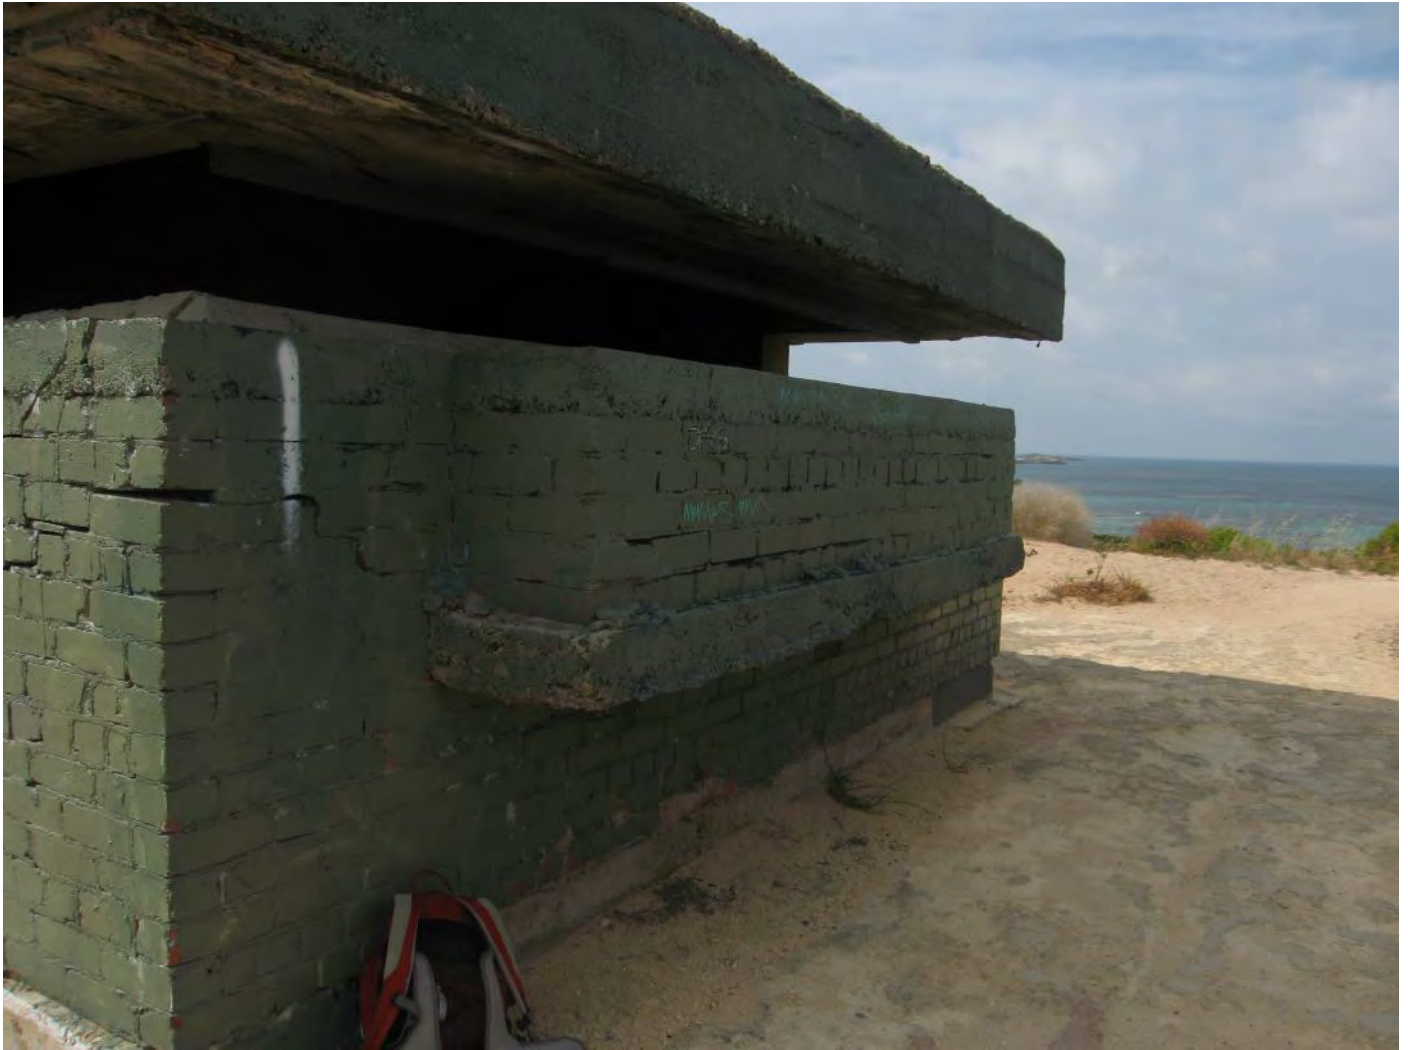
**Figure 60:** West Elevation - Observation Opening

The west elevation is the principal façade of the structure with clear observations over the coast line. The observation opening, embrasure, extends across the full width of the elevation before returning along the north and south walls. Immediately below the opening on the west elevation is a projecting storage area of brick and concrete construction which is in poor condition.

Research has shown that in similar structures, the ground level often came up to the bottom of these projection or slightly above providing support. Over time the ground level has eroded or has been manually removed to provide a flat walking surface around the structure which has removed all support for the projecting element. As a consequence, the weight of the projecting storage area is pulling the wall away from the rest of the structure which is evident in the cracking seen along the brick joints.

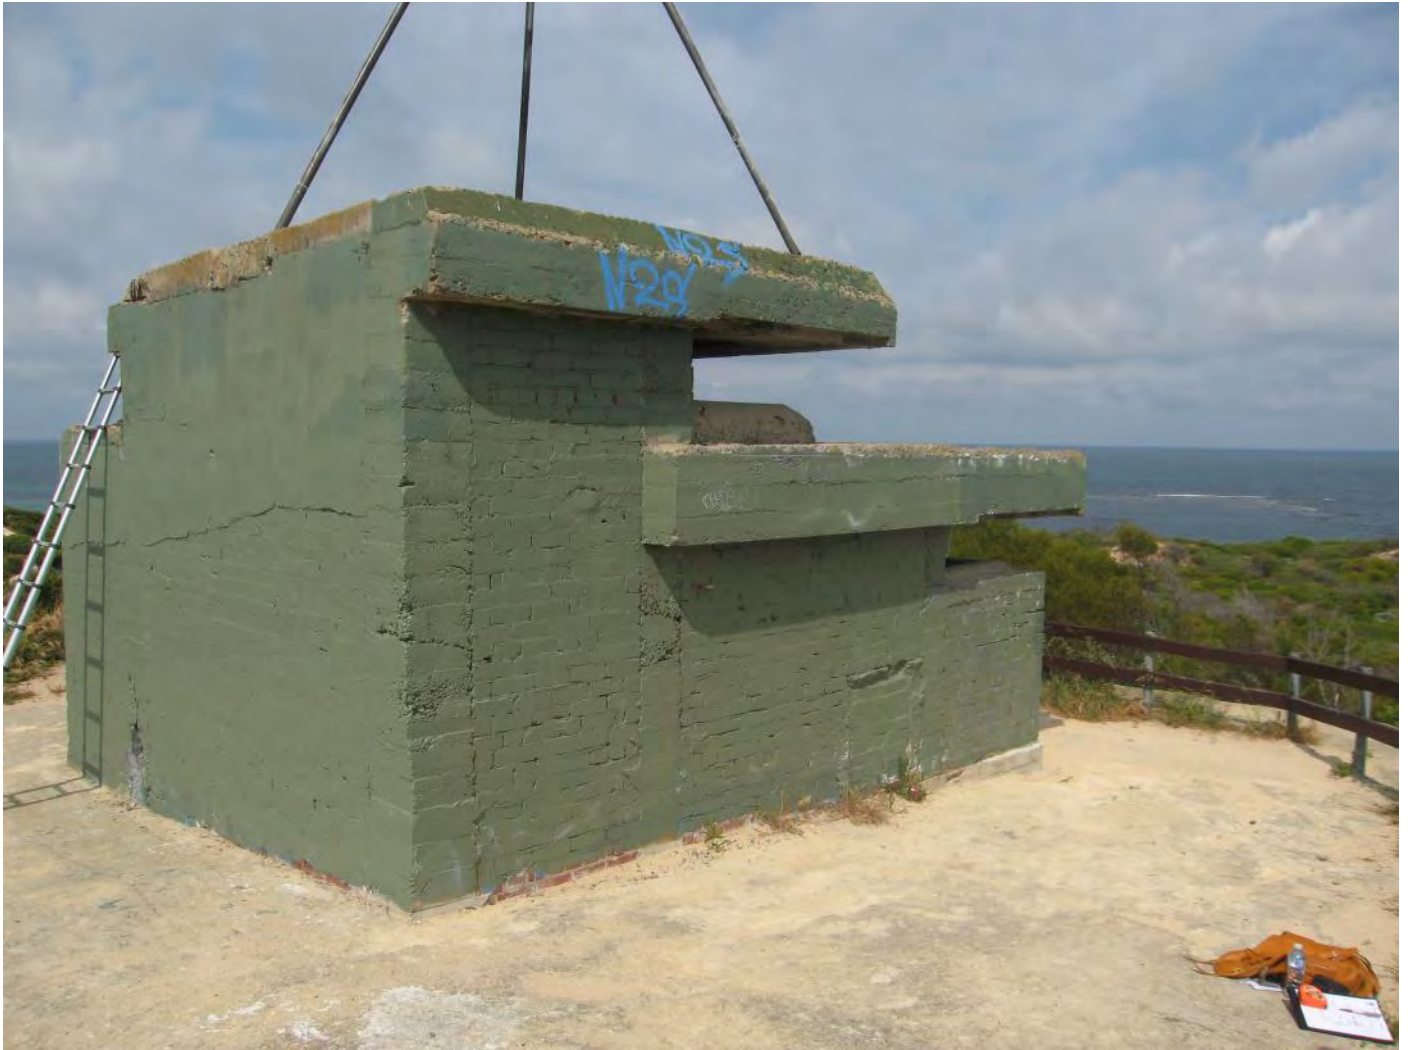
Figure 62: North Elevation

The north elevation is similar to the south elevation in terms of construction and presentation albeit with no entrance door. Again the concrete framework is visible with brick infill panels. A low level section towards the western end of the elevation has also been in filled. As the structures were decommissioned all the military equipment and installations were removed resulting in brick infill.

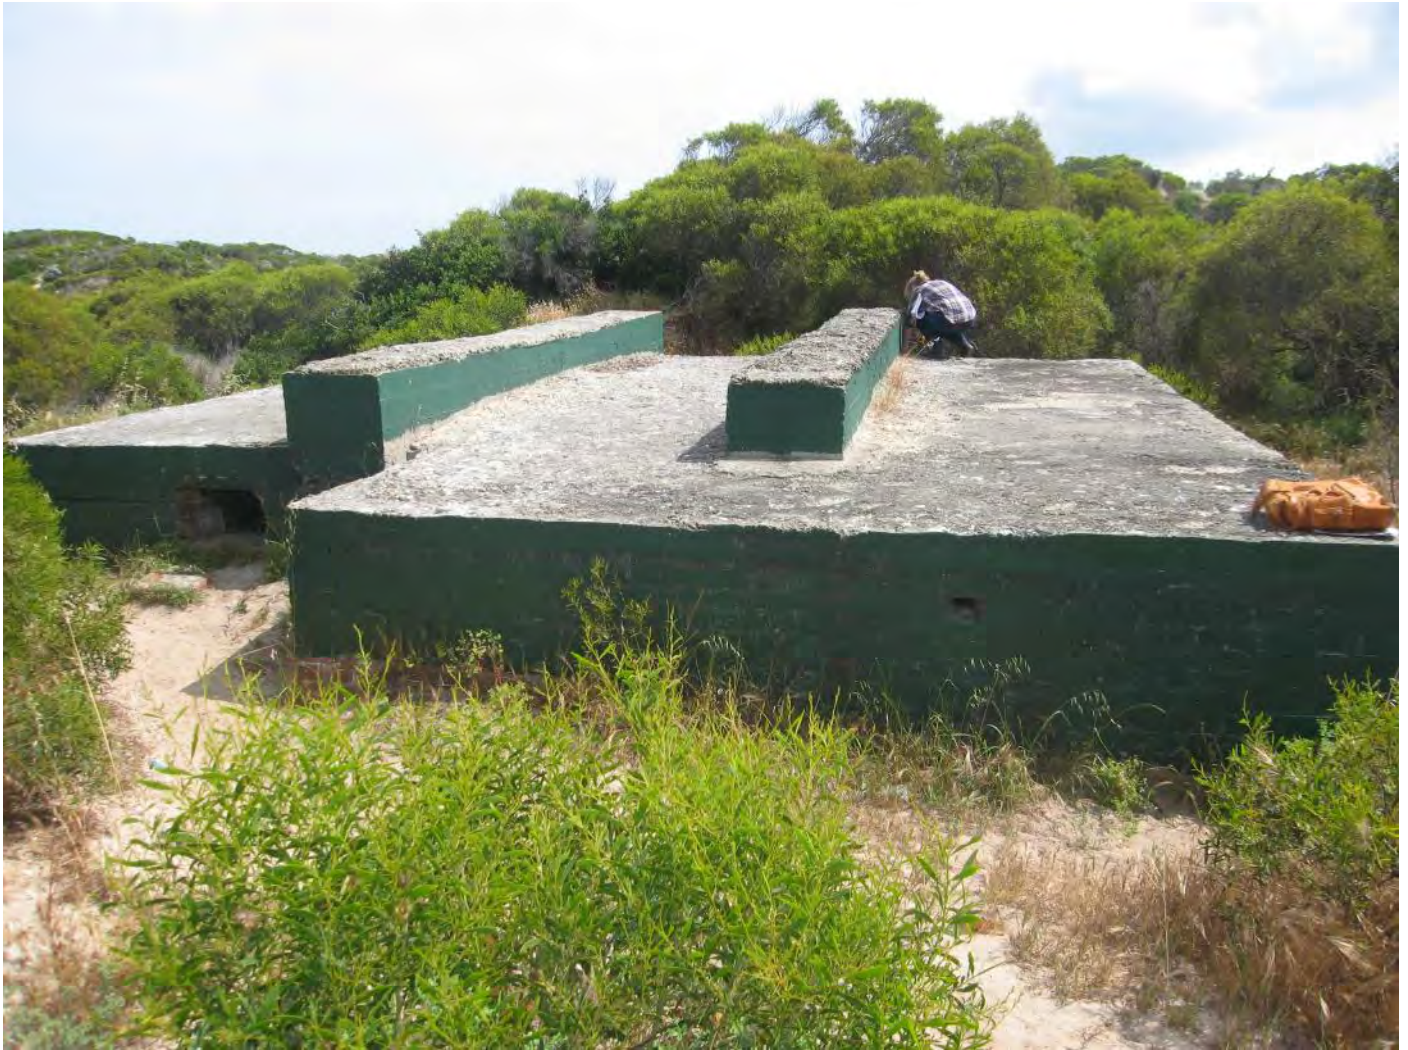
**Figure 79:**      **Operations Bunker – Roof plan**

The layered blocks of the concrete are visible in the reinforced beams, each being three slabs high with a roughcast concrete top layer. Sand accumulation around the base of the beams is allowing for grass growth along the beams.

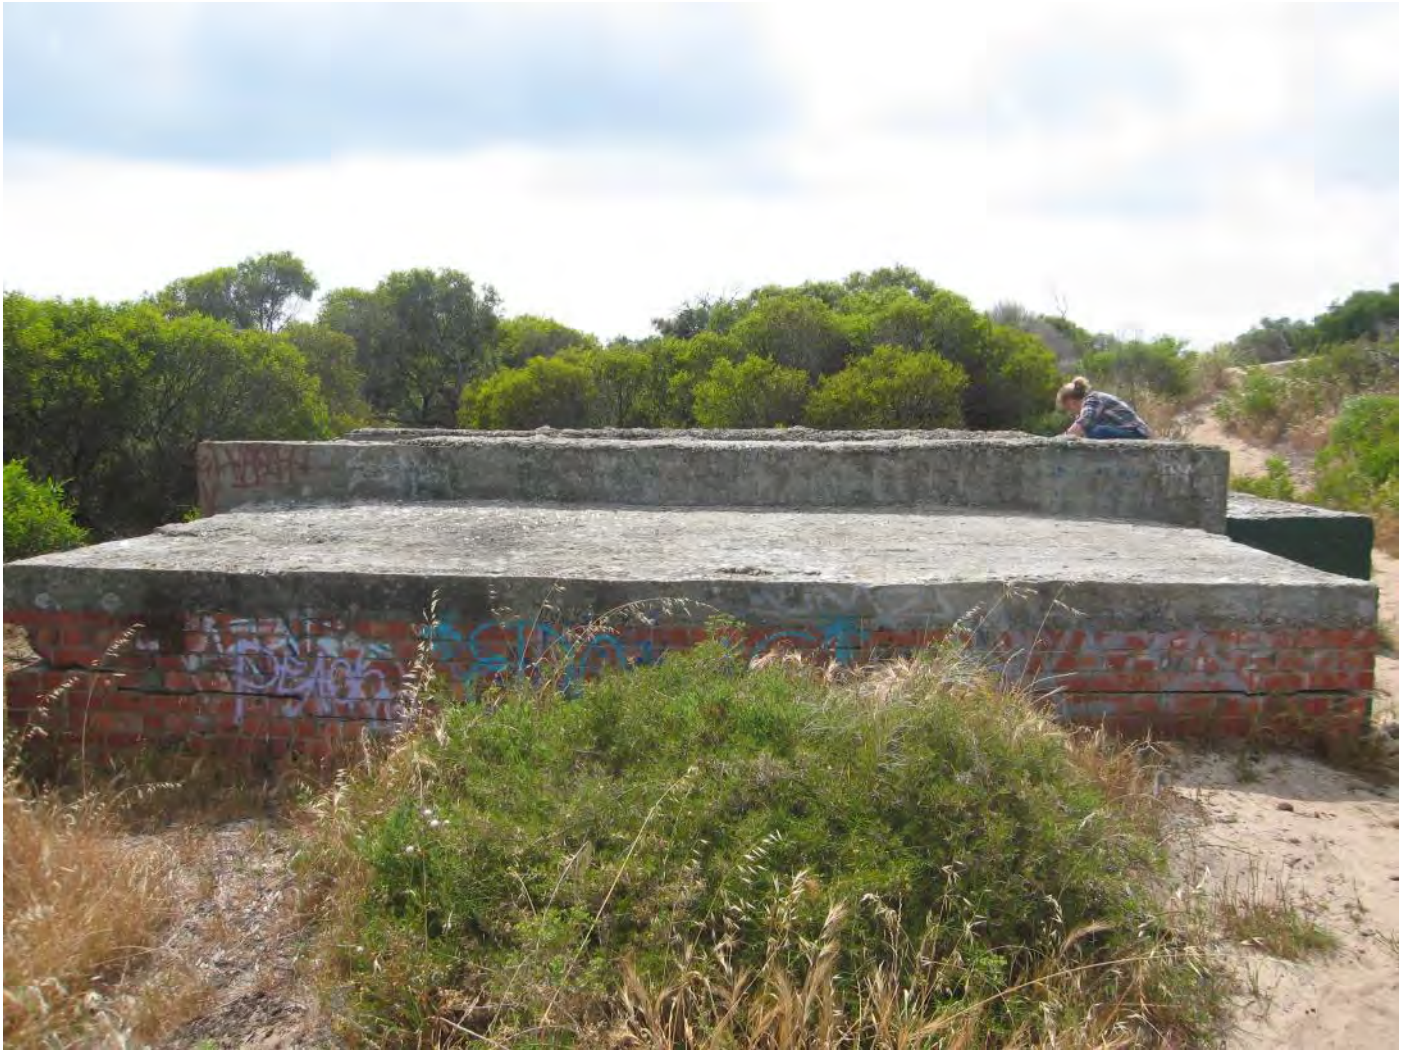
Figure 84: Operations Bunker – west elevation

The west elevation is largely submerged in the sand dune but the top ten brick courses are visible with an extensive crack extending along the full extent of the elevation, following the mortar joints. The crack is caused by the failure of the steel bar reinforcement in the brickwork which has rusted and expanded causing the brickwork to move and become loose. Brick from the north west corner are missing which will contribute to the continued deterioration of the brickwork and enlargement of the crack.

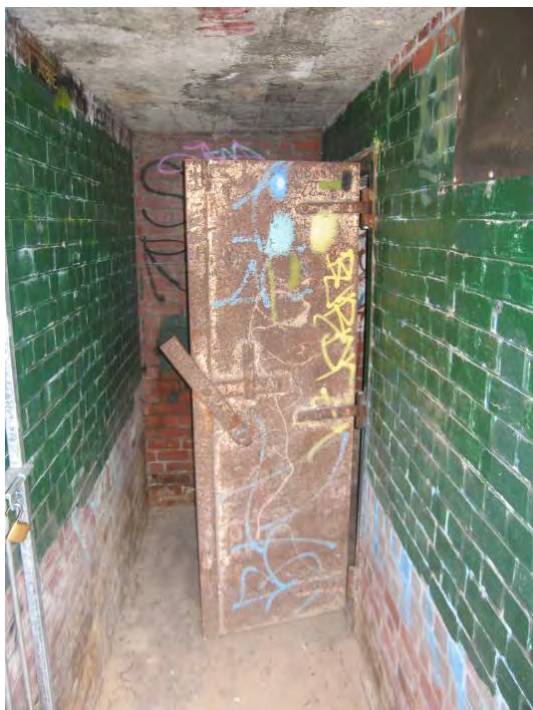
Figure 89: Operations Bunker – Extant steel entrance doors

The brick and concrete steps lead down into the entrance tunnel which is of brick construction with concrete floor and roof. The tunnel is about 3m long with the main entrance doors into the Operations Bunker being located at the far end on the south wall of the main building. The steel doors are the original heavy doors with each door being held in place with three hinges and locked by a pivot lock. The doors have been scratched and graffitied over time and are now presenting with surface rust.

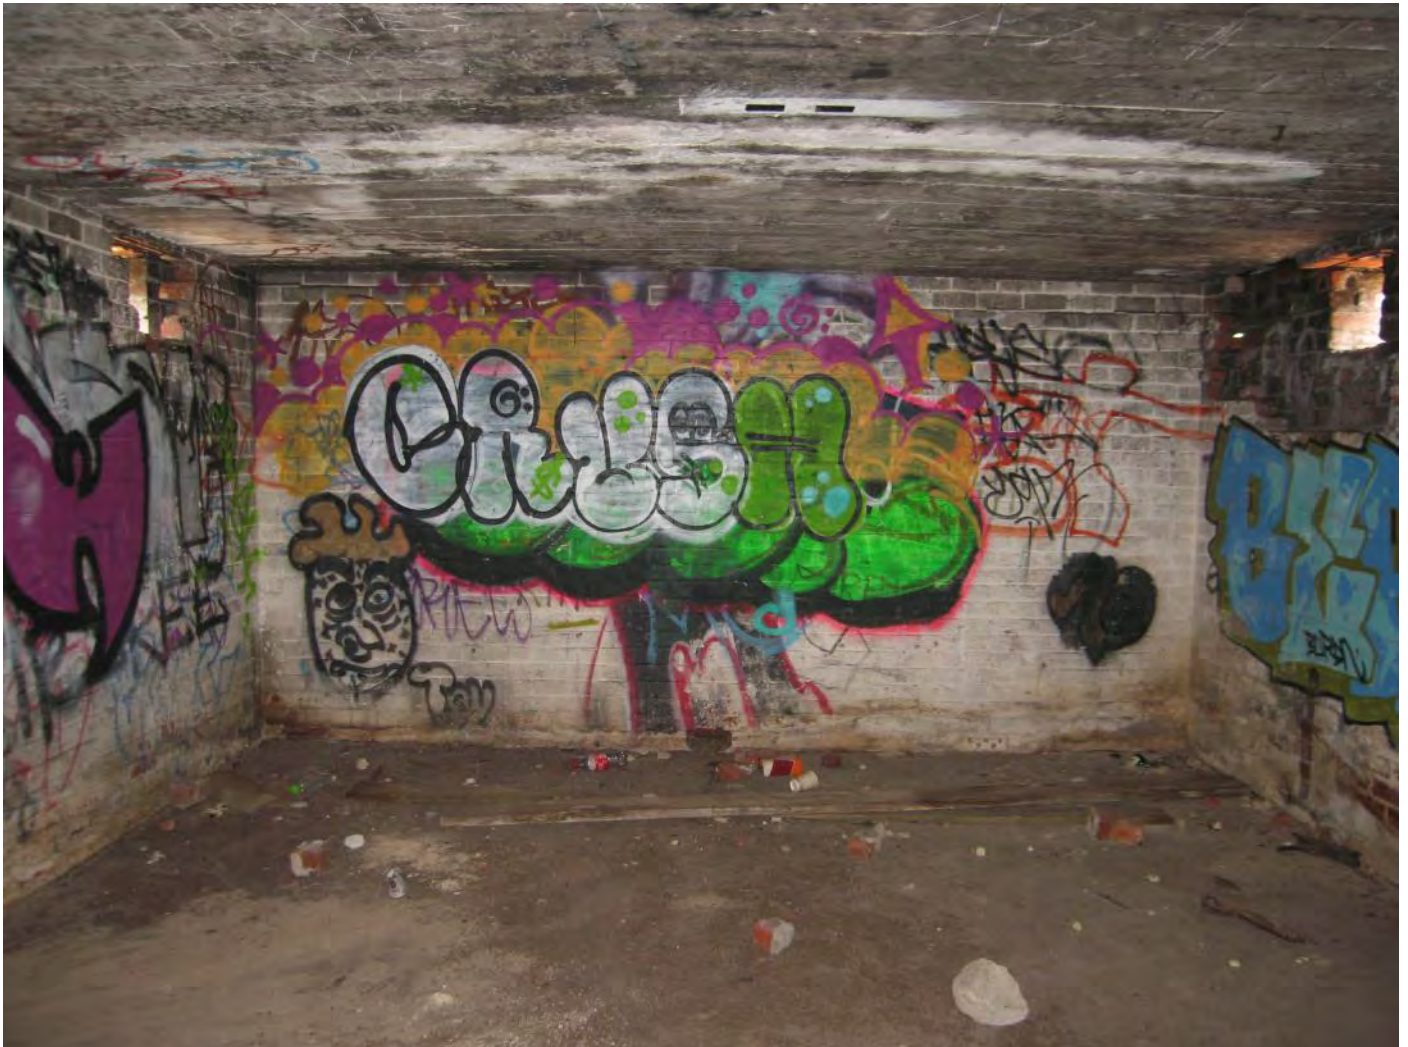
Figure 90: Operations Bunker – Interior (west wall)

The internal space consists of one rectangular shaped room of simple presentation. The brick walls are the internal leaf of the cavity wall which have been painted white at an earlier stage and are now covered in graffiti.

Loose bricks have collected on the concrete slab floor from the north west opening.

The bricks around the north west opening have become loose and fallen from the wall. This in part is due to the failure of the steel reinforcement in the brick wall but part of the damage can also be attributed to vandalism. The remainder of the wall around the opening appears to be in a stable condition.

The lower levels of the walls are showing some signs of damp, most of which is attributable to the build up of sand over the years and the inability of the fabric to breathe.

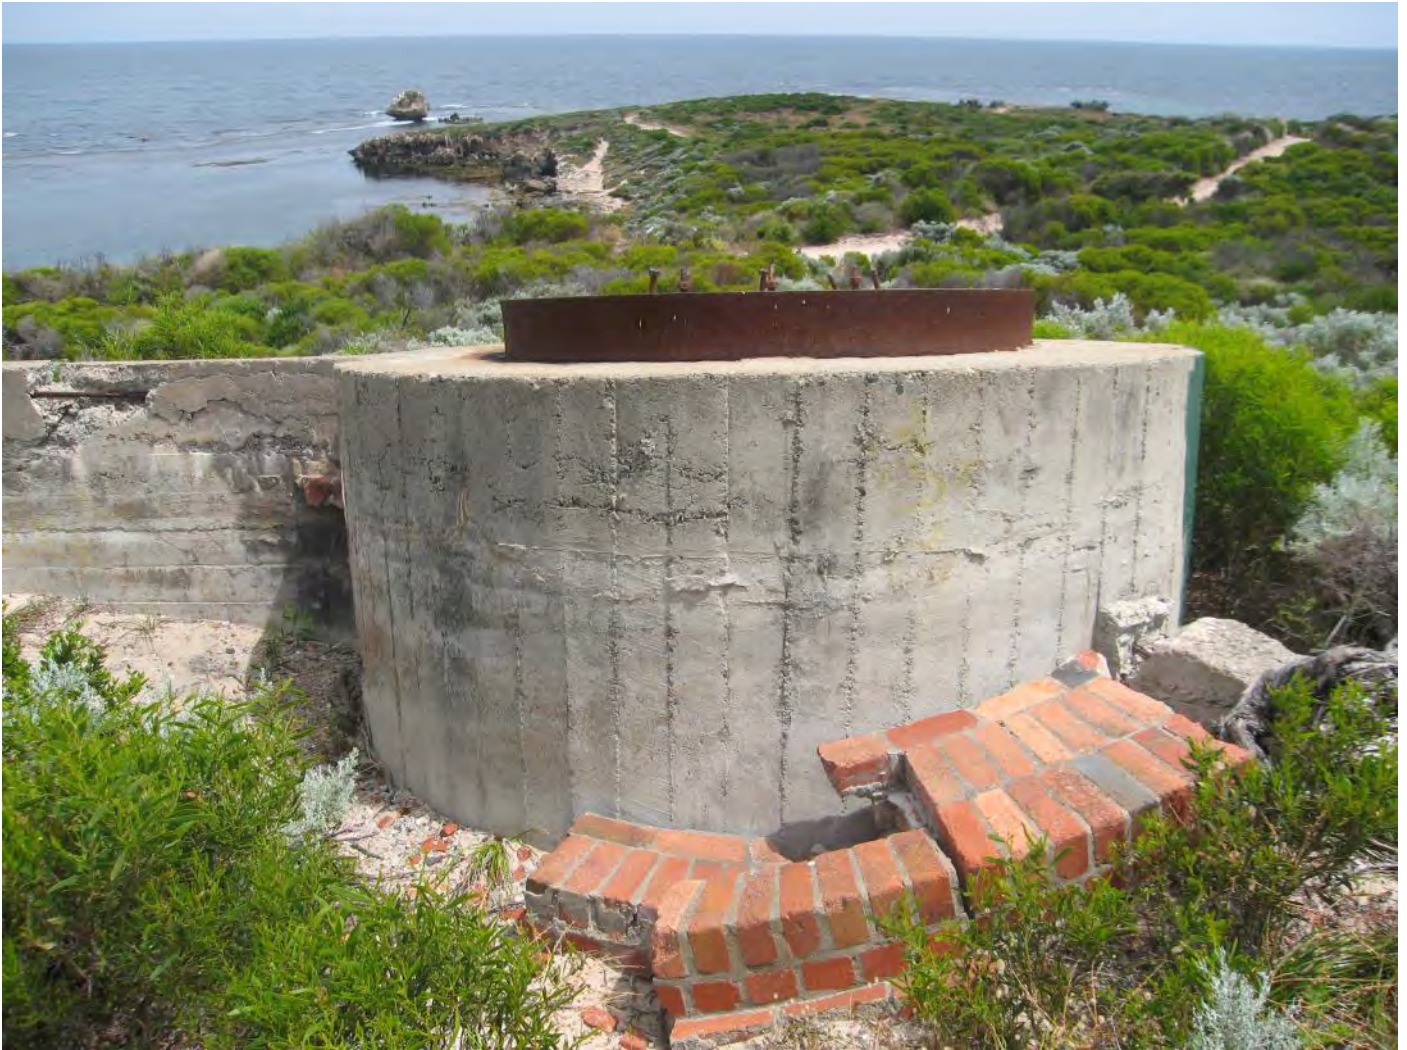
**Figure 100:**      **Gun Emplacement**

The central gun mount and the concrete walls are all constructed from reinforced concrete. Sections of the concrete have blown due to the rusting of the reinforcements displacing chunks of concrete.

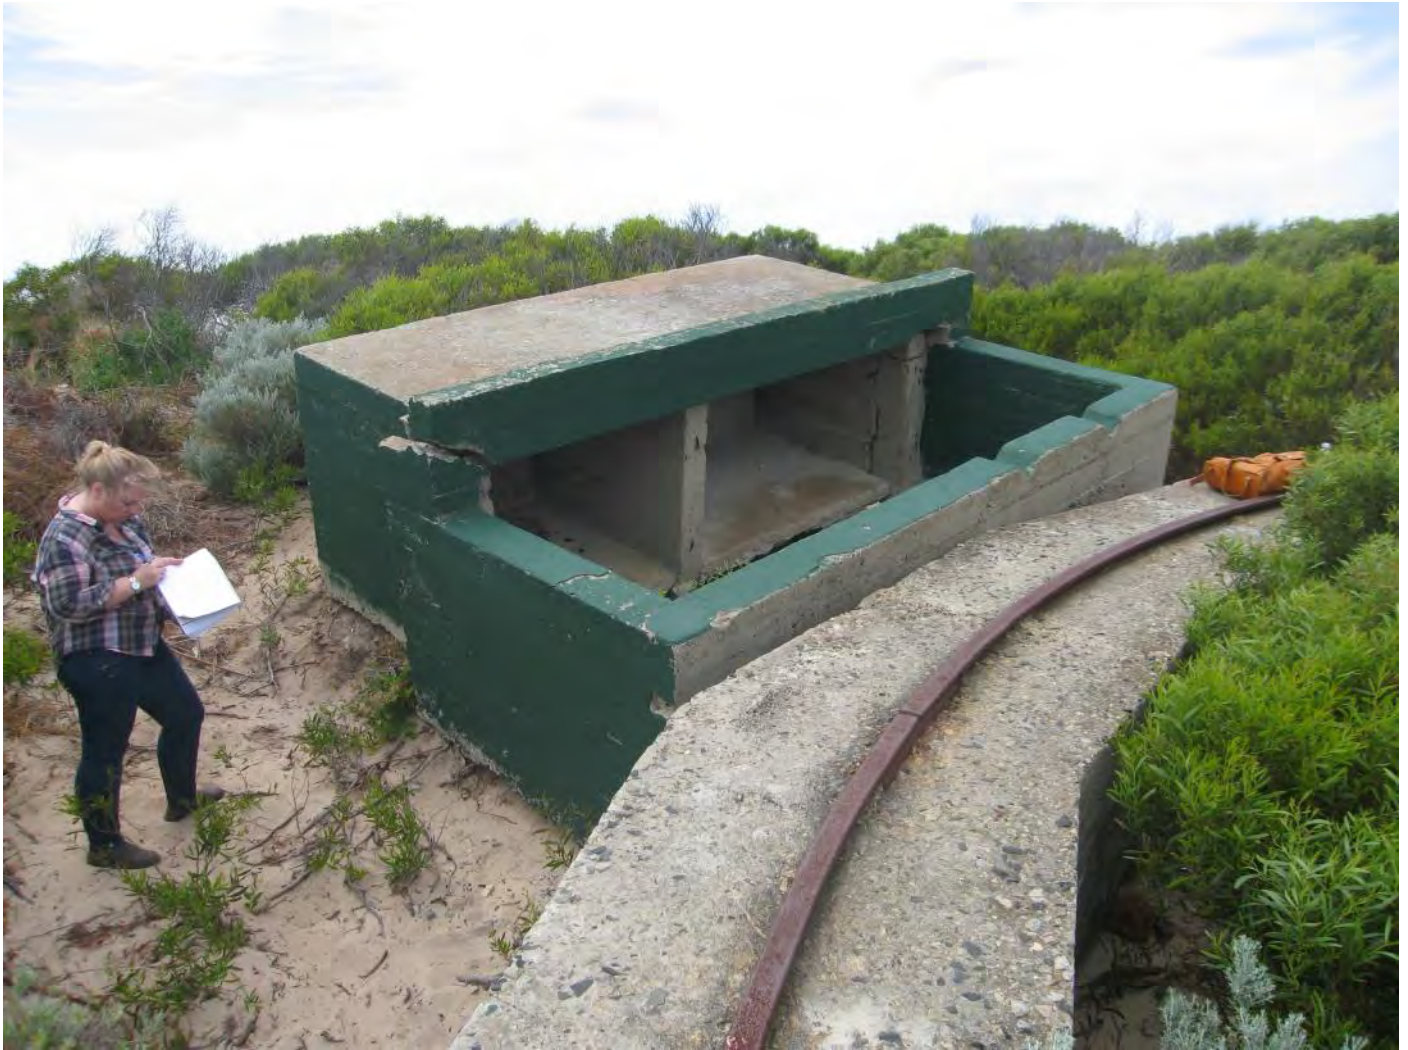
**Figure 106:** Gun Emplacement - Ammunition Store No. 1

The two ammunition stores are located to the north east and south east of the gun emplacement and are identical in form and construction, though both are in varying states of deterioration. As with the main gun emplacement structures, the two ammunition stores have also suffered as a consequence of the ground shifting. Store No. 1 which is located to the north east of the gun emplacement has moved forward and slipped into the retaining wall of the gun emplacement.

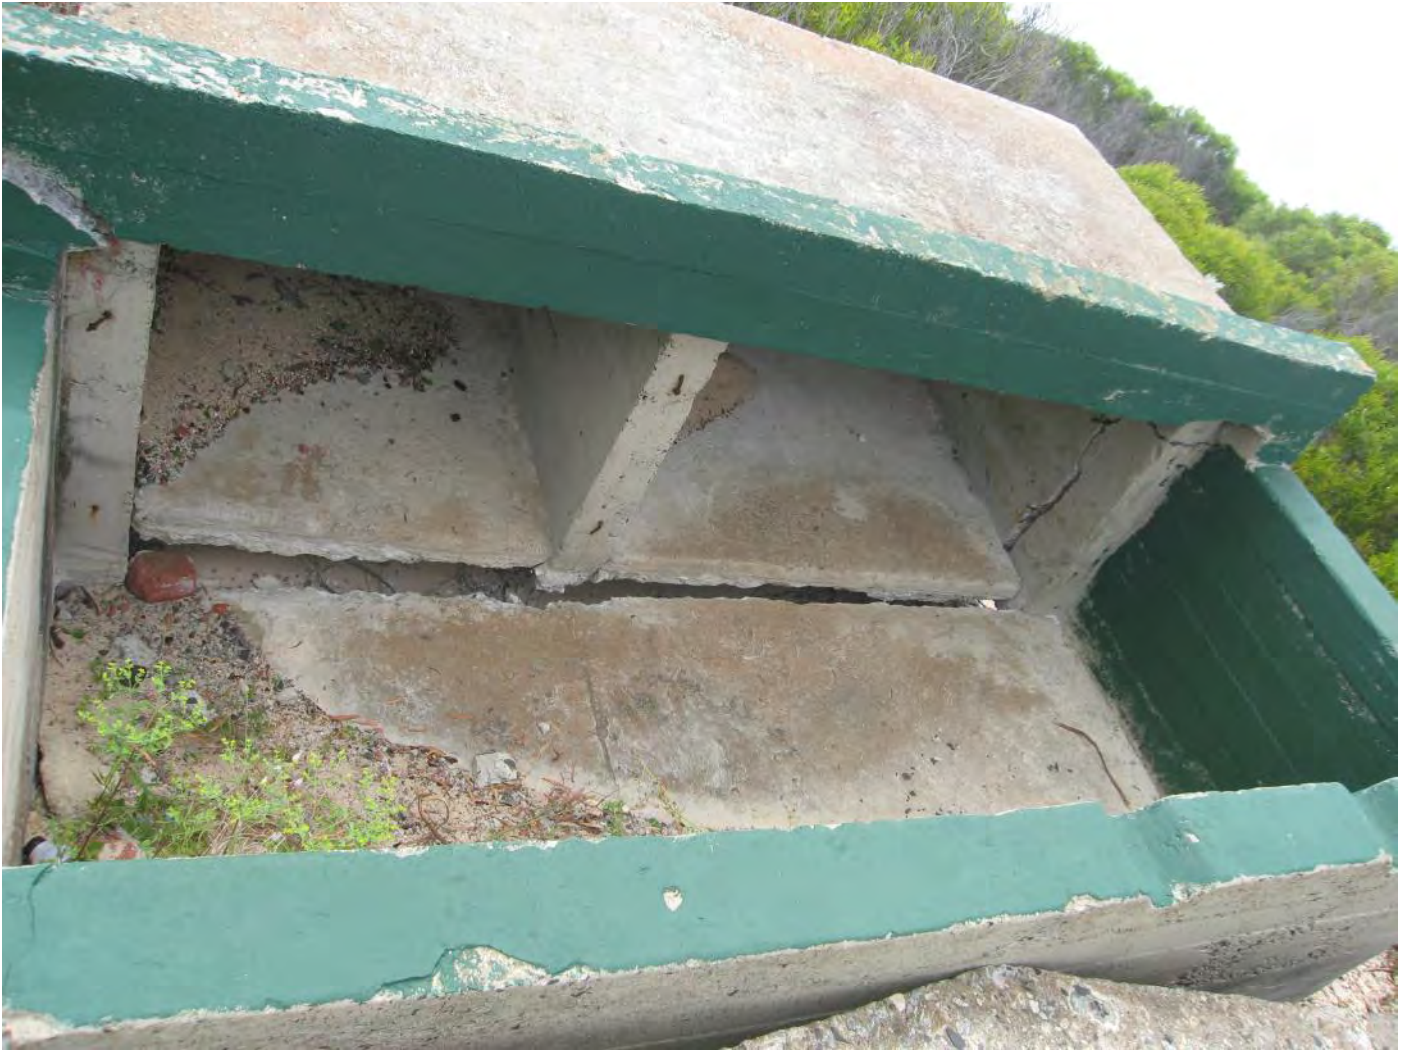
Figure 107: Gun Emplacement - Ammunition Store No. 1

Whilst the structure has remained predominantly in one piece, cracks have occurred in the concrete and the floor of the two store rooms has become displaced. Despite the movement, the concrete walls have remained in tact.

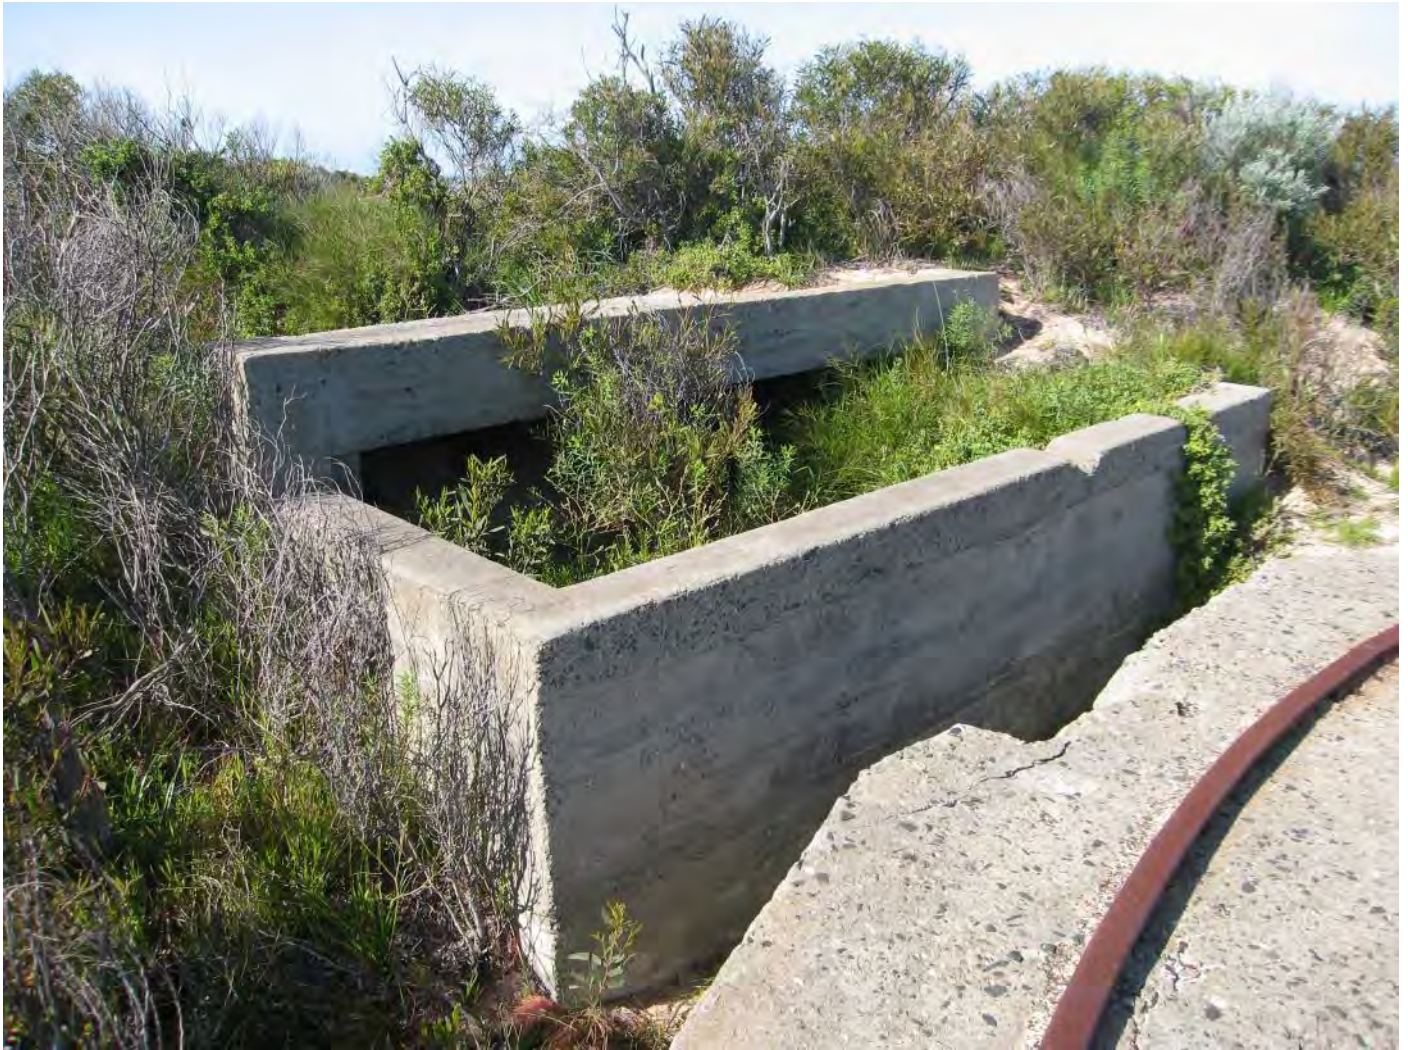
**Figure 111:** Gun Emplacement - Ammunition Store No. 2

Ammunition Store No. 2 is positioned to the south east of the gun emplacement and looks to be in, or close to, its original position. The structure has become largely submerged in the sand with the majority of the structure being obscured from view. Sand has accumulated on the roof and internally resulting in the growth of vegetation which will ultimately contribute to the deterioration of the concrete structure.

As far as can be determined, Ammunition Store No. 2 appears to have remained in tact with no obvious signs of cracking or displacement of the elements.

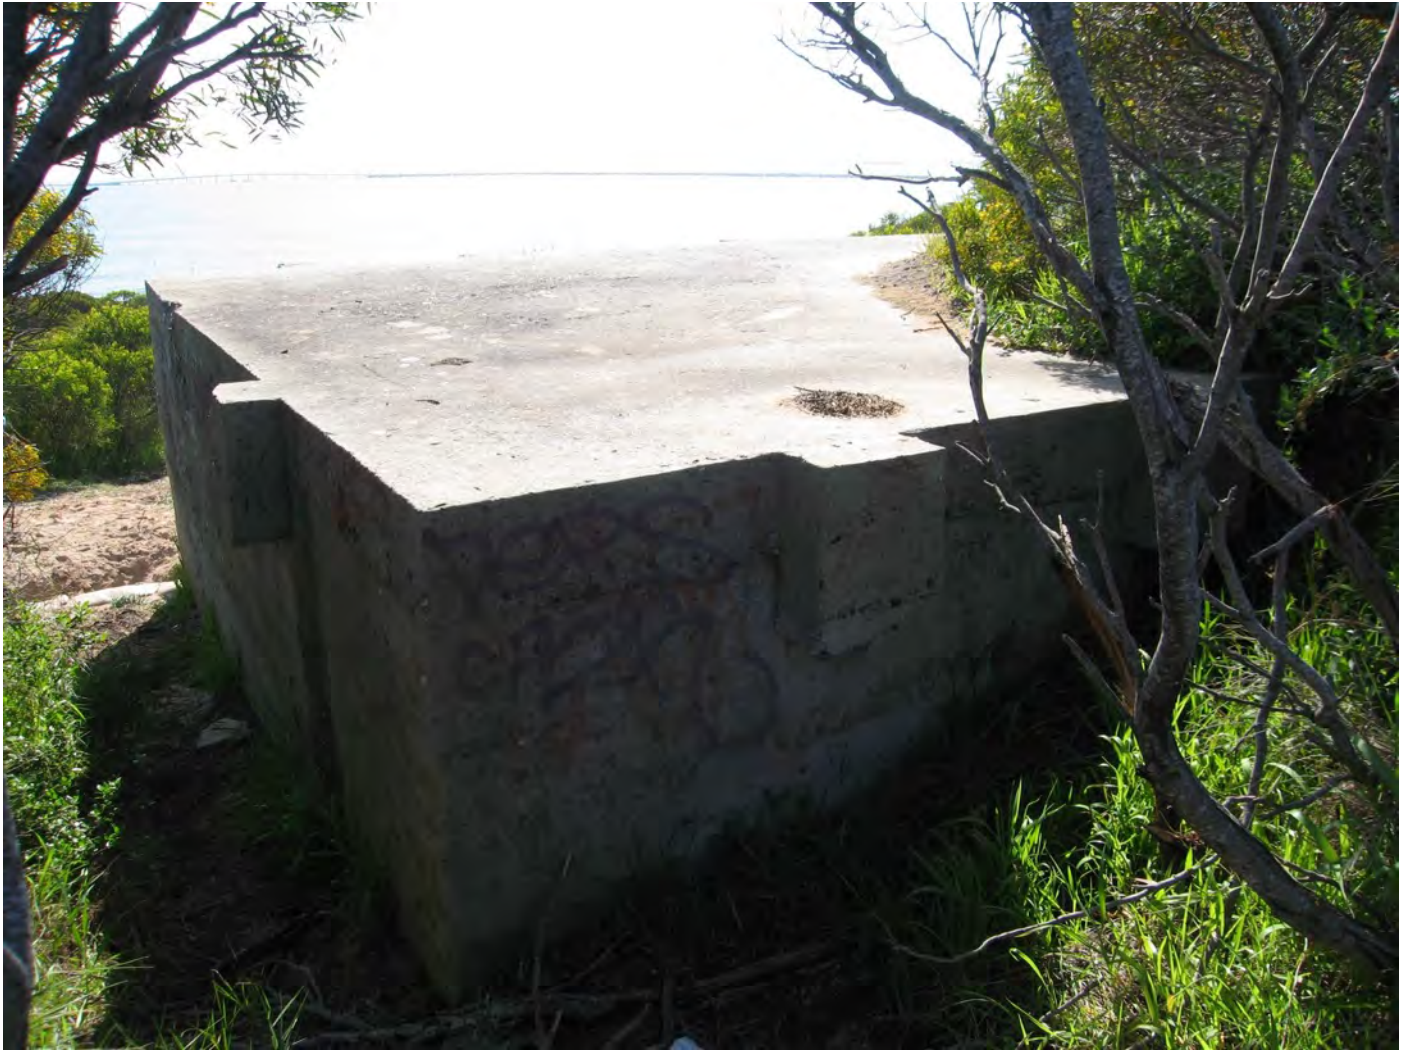
**Figure 118:** Ammunition Bunker – view across the roof

The Ammunition Bunker is a simple structure bearing similarities to the plan form and construction method of the other structures around the site. The external walls are of reinforced concrete construction with the roof being a reinforced concrete slab. Projecting vent shafts are placed at regular intervals around the building, level with the roof and extending down to approximately two concrete slab courses. One of the shafts on the north elevation has fallen off revealing a small opening in the wall.

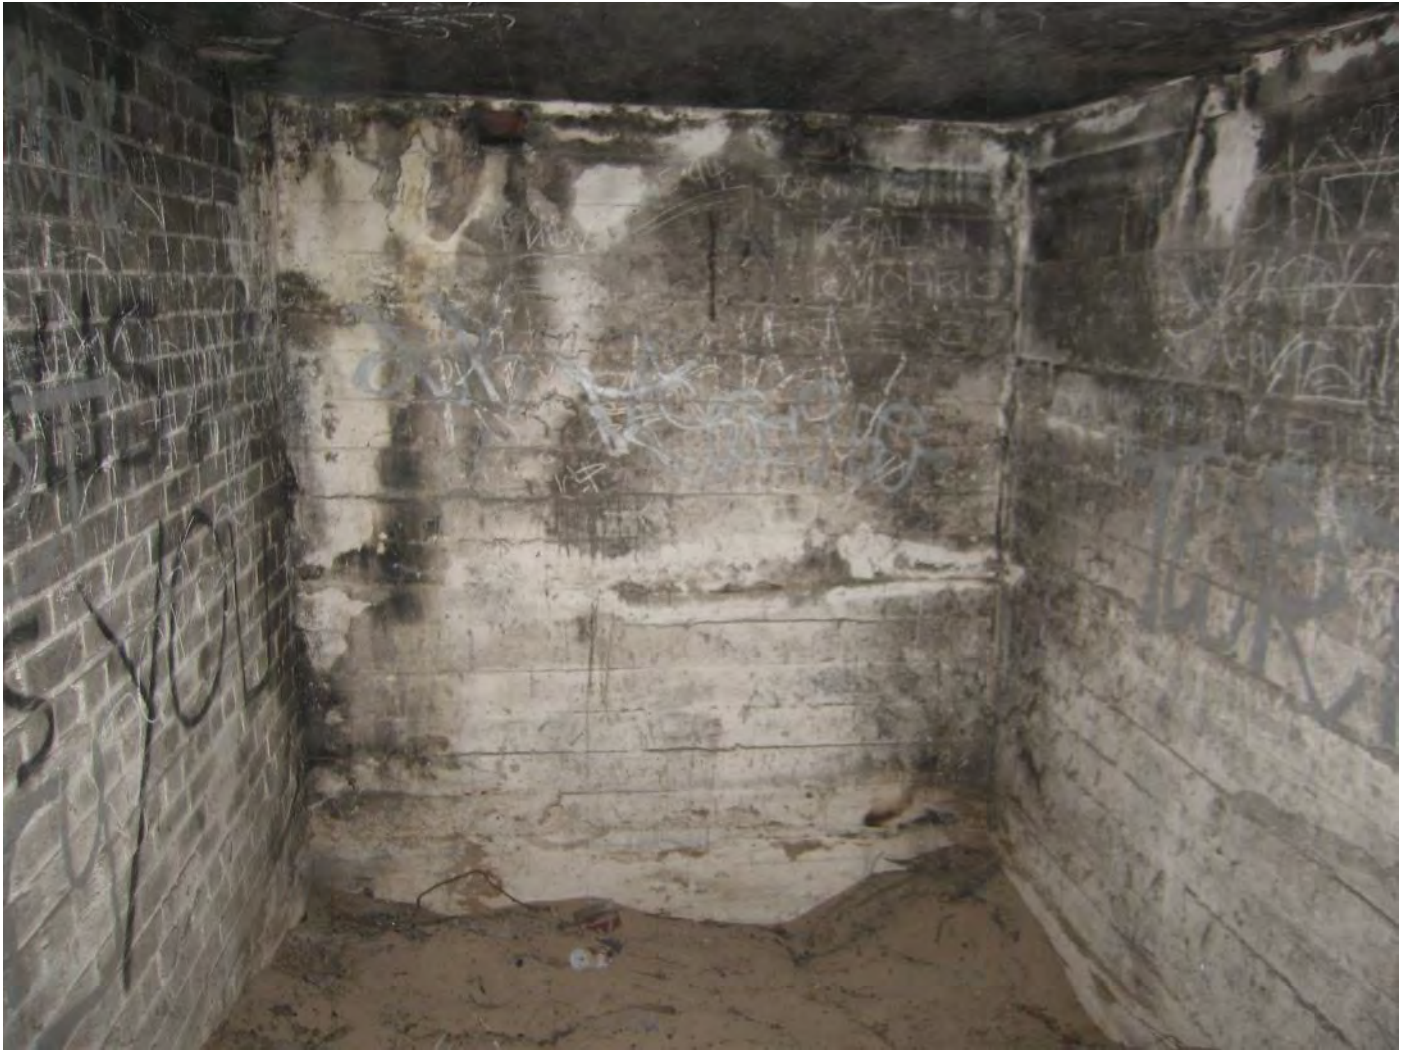
Figure 122: Ammunition Bunker – Room 1

The walls are a dusty white with graffiti with damp staining and possible fire scorch marks.

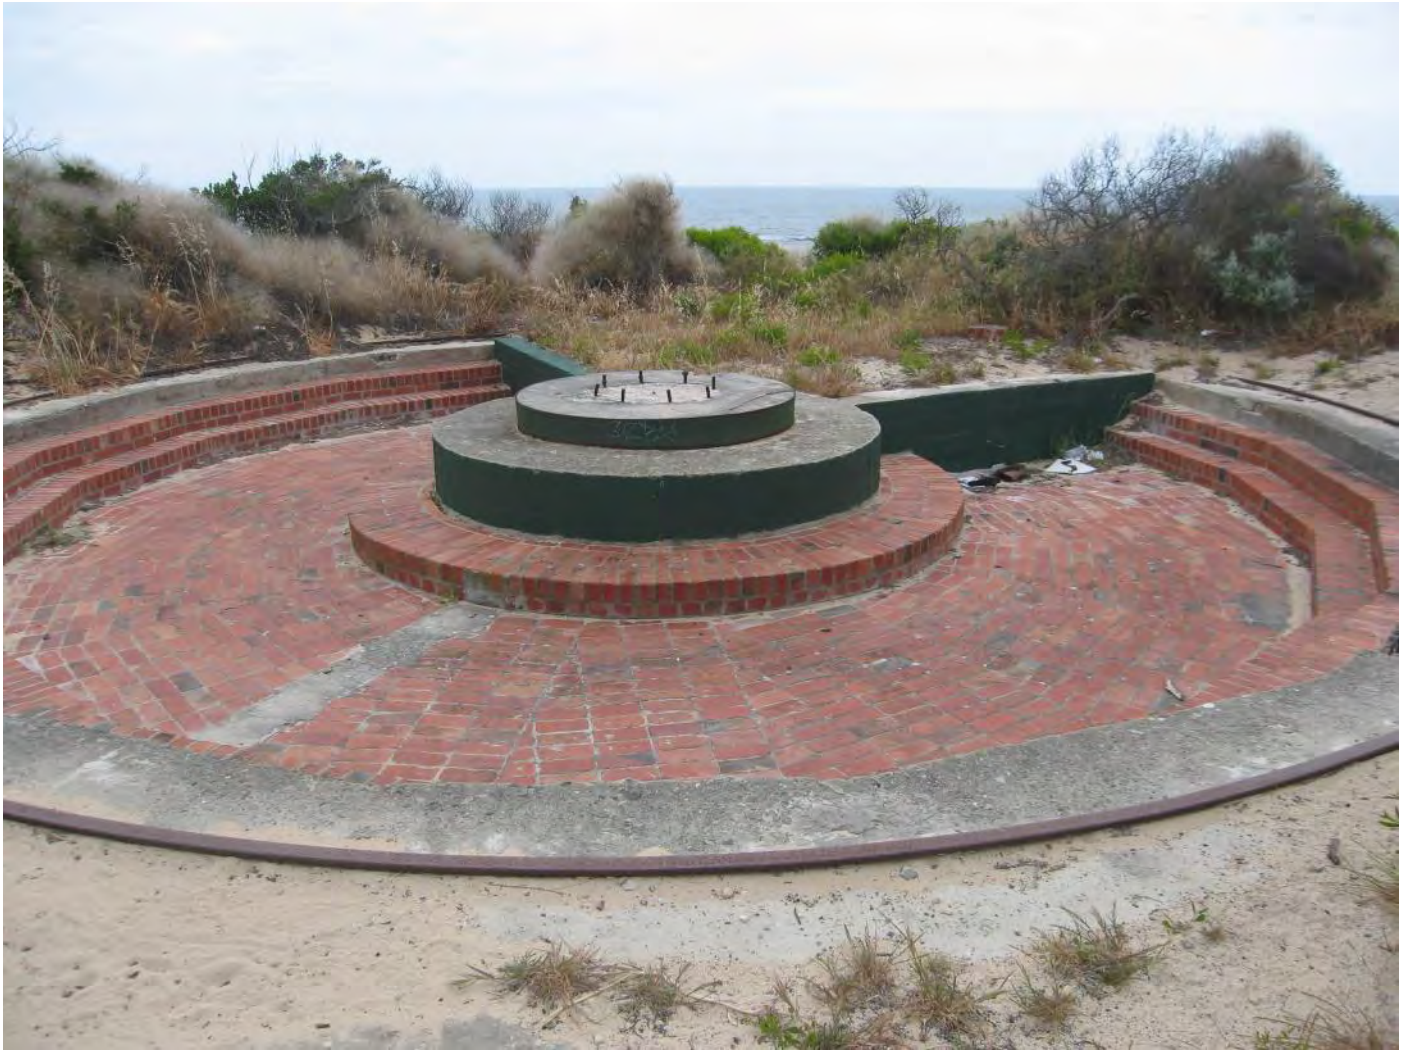
**Figure 129:**      **Gun Emplacement No. 2**

Gun Emplacement No.2 is exactly the same as the Emplacement No. 1 apart from its condition. Gun Emplacement No. 2 is intact and presents as originally constructed which aids understanding of the form and function of the structure.
