# Point Peron "K" Battery Conservation Management Plan

South West Corridor Development Foundation Inc.

March 2016

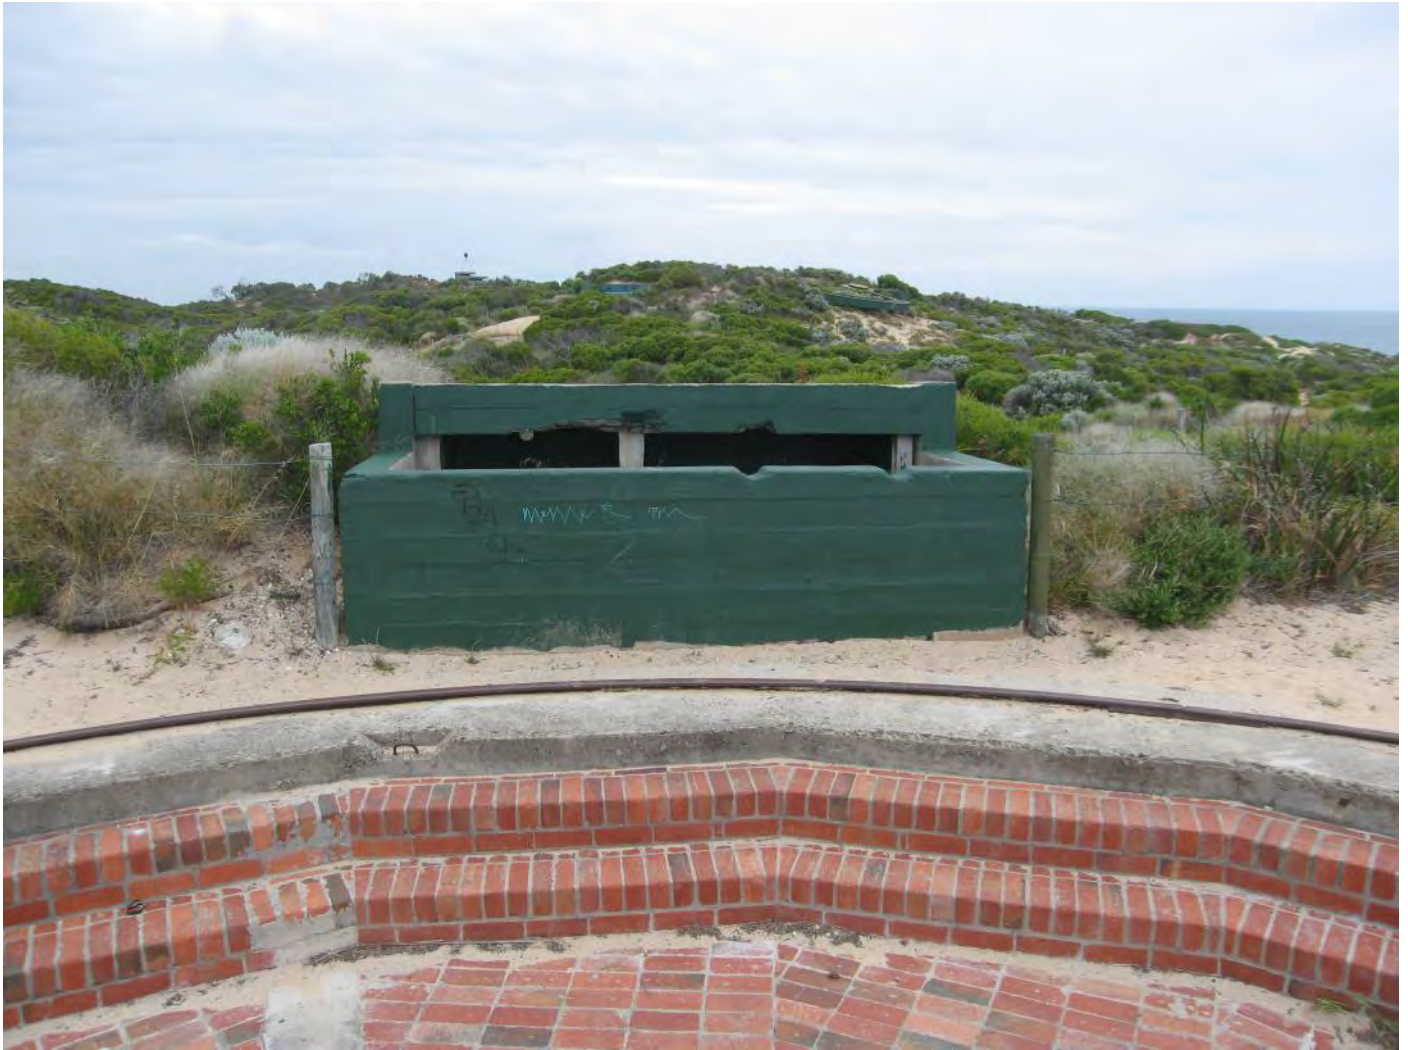
**Figure 134:** Gun Emplacement No. 2 – Ammunition Store 1

Both are in good condition and clearly demonstrate the plan form of the structures. Both are partially obscured by the sand around the sides and the rear of the structures but not to any great detrimental effect.

Though generally in good condition, the concrete is beginning to show early signs of concrete cancer in places, especially to the edge of the roof slab where chunks of concrete have broken away and the rusted reinforcing steel is visible.

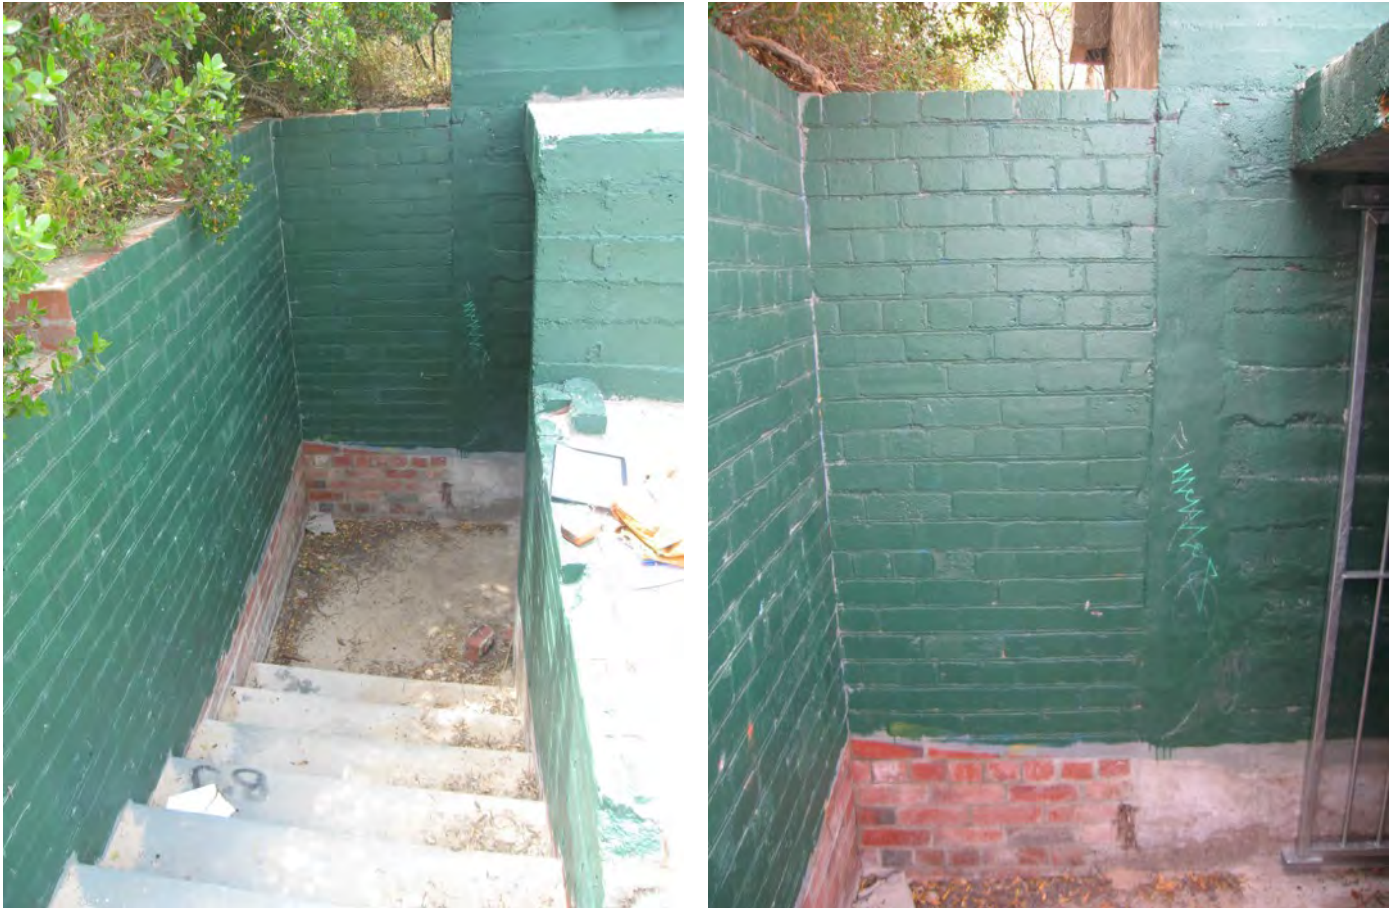
**Figure 143:** Ammunition Bunker No. 2 – Entrance

The entrance is located on the south-west elevation with the concrete steps projecting out from the main building line of the structure, before doglegging to the right and accessing the Bunker. The steps are protected by twin brick retaining walls, the majority of which have been painted with only the lower brick courses remaining in the natural state. Sand accumulation prevented the walls being painted fully to ground level. The brickwork is laid in English Garden bond consisting of three stretcher courses followed by a header course. The terminating brick wall at the foot of the steps abuts the concrete frame of the bunker structure and has not been keyed in.

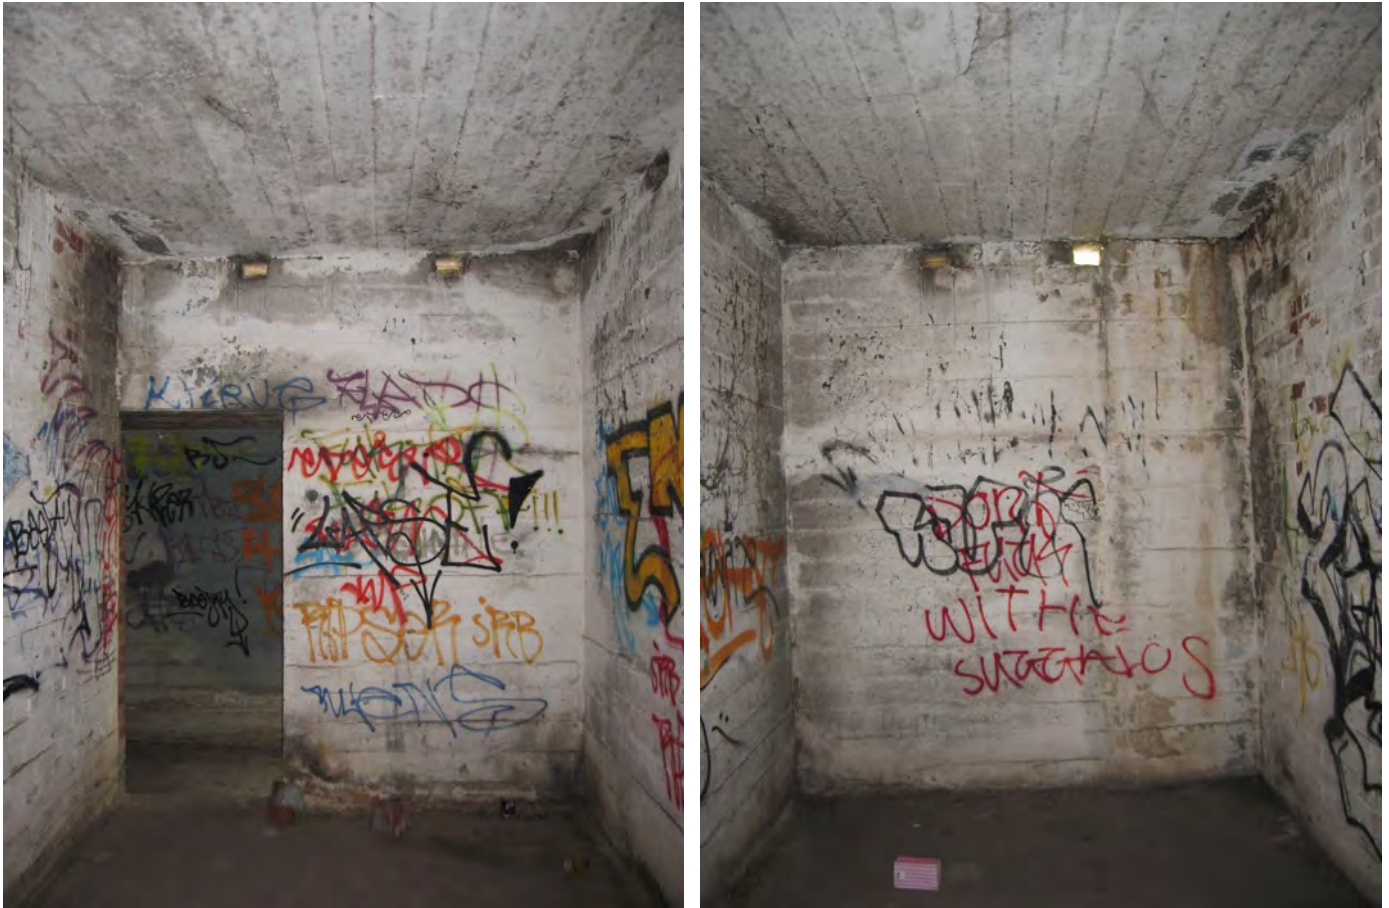
Figure 146: Ammunition Bunker - Room 1

Internally, the bunker has the same plan form as Bunker 1 with the main space divided into two rooms plus an entry tunnel. The smaller room, Room 1, has three external concrete walls with a fourth double leaf loading bearing brick wall dividing Room 1 from Room 2. The concrete to Room 1 has been painted white which is wearing off and has been covered in graffiti. Small ventilation holes are positioned directly below the ceiling. The sand has been removed but the walls are showing slight signs damp at lower level which may dry out now the sand has been cleared.

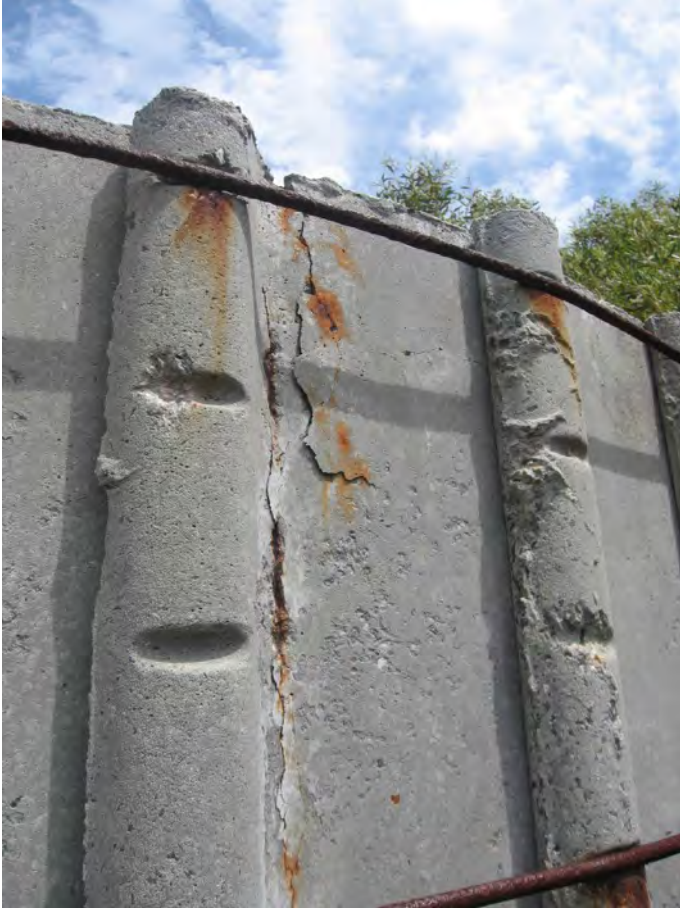
The roof is no longer extant with remnant corrugated iron and timber laying in the bottom of the tank and around the edges.

Figure 152: Water Tank

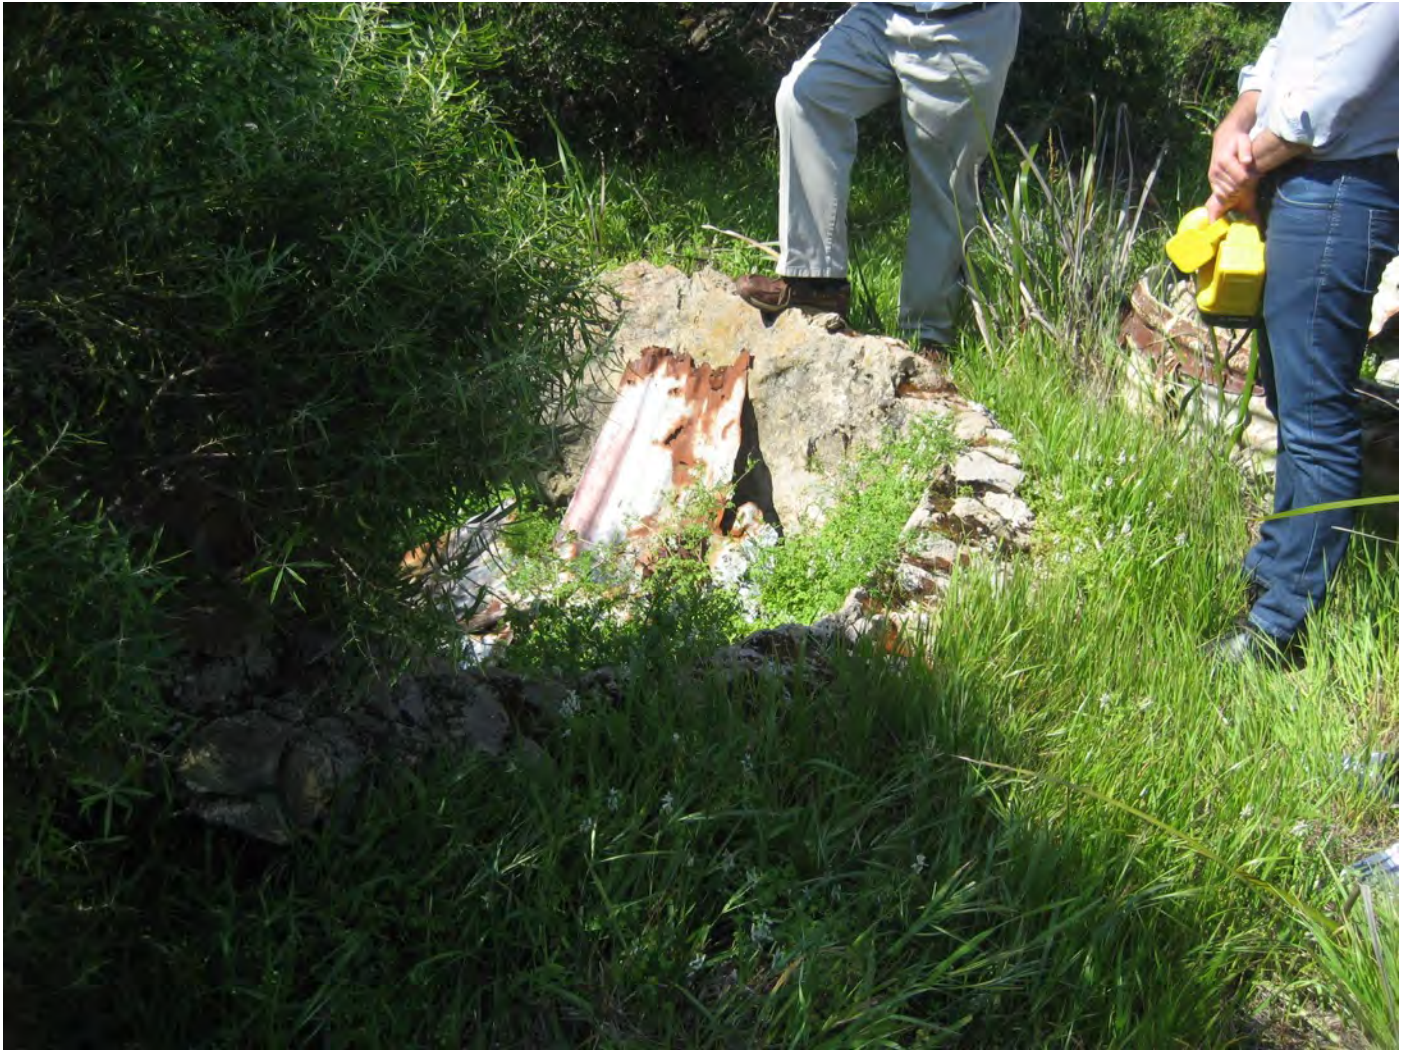
The remnants of the well consist of a circular stone lined void of indeterminable depth. Remnant corrugated iron sheets are laying in the well which may have formed part of the well lid. The well is now full of building debris, sand and weeds.

Figure 159: Well

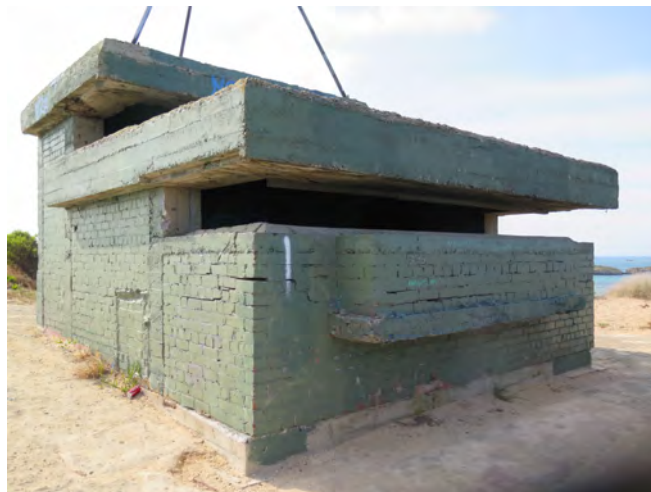
## 3.1 Observation Tower

The overall condition of the building is good given the original quality and speed of construction, its intended design life at outset, its atmospheric exposure and the levels of maintenance seen since decommissioning.

From the experience of similar sites it is most likely that the rapid acceleration of concrete cancer is not far away. With the cost and invasiveness of concrete repairs, the large scale concrete repair of such structures is likely to be both financially prohibitive and undesirable from a heritage viewpoint due to the scale of fabric loss. A more realistic approach to adopt is that of a managed ruin whereby efforts are focused on measures to slow down the onset of cancer as much as possible. Ultimately cancer will develop but with appropriate measures put in place, particularly those against water ingress and those promoting local and global drainage of surfaces, the timing of such can be slowed down significantly. The building's life is consequently extended significantly as a result.

- i) Re-screeding of concrete roof tops to good falls and with waterproof membrane or acrylic barrier.
- ii) Covers to look out openings at each levels.
- iii) Cover to entrance door opening.
- iv) Possible local concrete patch repairs and/or 'benching' of local surface to improve drainage.
- v) Corrosion inhibitor and epoxy/acrylic barrier coatings to exposed external concrete surfaces.
- vi) Carbonation barrier and corrosion inhibitor coatings to all internal concrete surfaces.

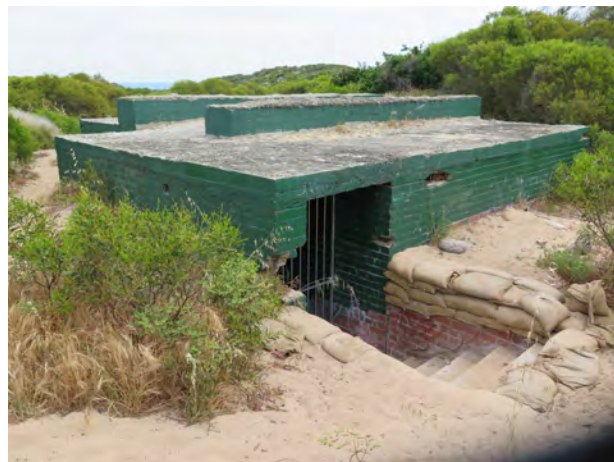
As for the Observation Tower, the structure has fared well given its history. The most vulnerable element on the face of it, the concrete roof slab, is in good condition without widespread cancer damage. Consistent damage has occurred however in the high level courses of the perimeter brickwork onto which the slab immediately drains. Horizontal steel bar bed reinforcement has been used at one course down in the two leafs of brickwork. These have corroded and expanded significantly in locations, particularly at the building corners. Here corrosion forces have been high, sufficient to jack up slab corners and push local brickwork off the building both externally and internally. This is both the most important condition issue and most important safety issue facing the building.

Shifting external ground levels has clearly occurred over time with erosion appearing to dominate the West side and deposition the East. This has not affected the structure much except to increase exposure to lateral moisture penetration on the East side and block the entry (now cleared). Additional lateral pressure is exerted on the brick retaining walls of the entry approach but to no effect as yet since entry clearing work. There has been undermining of the small brick vent shafts on the north side, these have consequently fallen away.

The subject steel causing the high level problems in the brick walls was and remains in fact of little use structurally and is best removed from the structure for the long term good. A systematic approach to raking out joints and removing bars can be used in conjunction with brick and crack repairs.

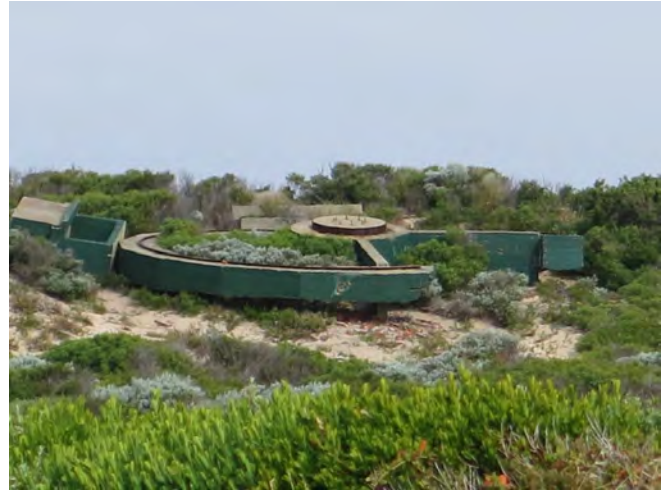
The structure exists in precarious dramatic equilibrium between shifting ground supports and its own structural ability to cope with these shifts. It has variously settled, twisted, snapped, slid, dragged, slumped and rotated in all planes with the natural erosion of the supporting dune.

The concrete strip footing of the stay track has been severely undermined and now spans in beam action to where support can be gained from either the dune or radial walls. It has failed in torsion on the North side trying to do this. Steel reinforcement has yielded and a new temporary equilibrium found until further dune erosion brings about a worsening of support conditions. A good deal of the South wing of the footing is suspended and with similar problems. The central concrete pedestal has been partially undermining but has tipped to the North with the weight of the stay footing imposed on it via its wing wall. The brick paving has all but fallen away and the northern munitions store has tipped and slid as a unit in the direction of sand shift, its base breaking up under the movement. The Southern munitions store remains the most stable of the site's features although this too has developed a lean towards downhill.

Some additional concrete repairs beyond those for concrete cancer would also possibly be necessary due to the structural damage incurred under dune movement. The scale of these will depend on the scheme selected for re-supporting the structure.

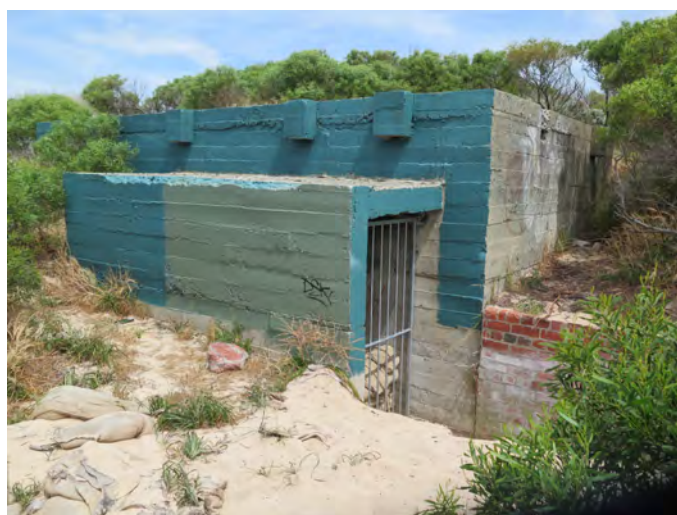
The concrete components have performed remarkably well. Clear concrete cancer is very limited in it's occurrence – at the base of external vent hoods only. The building's location on high ground with good falls away from structure and good drying conditions have benefited the

structure well. There is water ingress occurring through fine cracks in the roof slab and lateral ingress is taking place in the rear wall against which external sand build up has occurred, but this has not developed into visible concrete cancer to date.

The principals and actions outlined in 3.1.3 for the Observation Tower apply here. Whilst concrete is in much better condition here, the advances made by carbonation and chloride fronts still need to be known in order plan for the structure's future management. No issues are anticipated for the concrete ground slabs, covers to openings serve to protect against moisture ingress into the fabric generally.

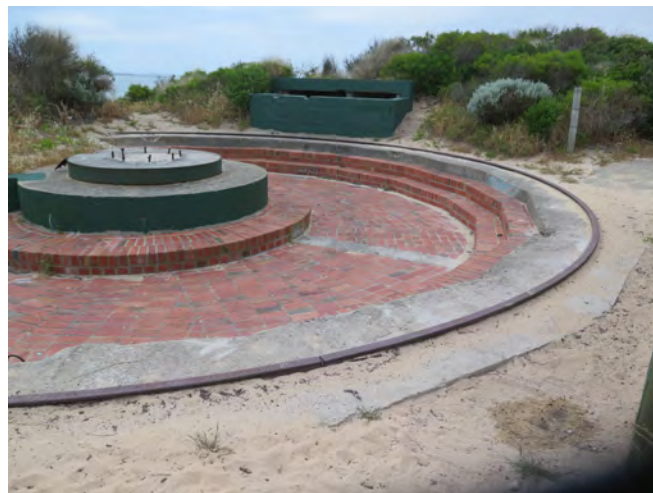
The emplacement remains are in good general structural condition. Shifting soil issues do not appear to have adversely affected stability of this site unlike the Emplacement 1 site. Concrete cancer is evident on the soffits of the munitions stores' roof slabs but the gun mount is relatively unaffected.

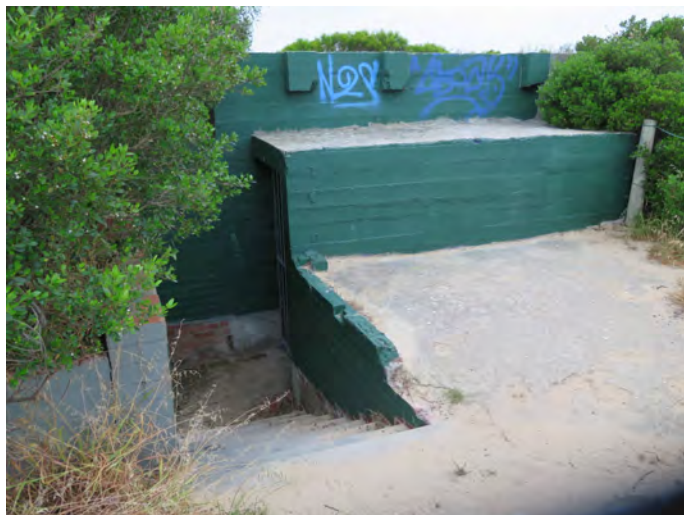
The building is similar in construction and condition to the bunker at Gun Emplacement 1.

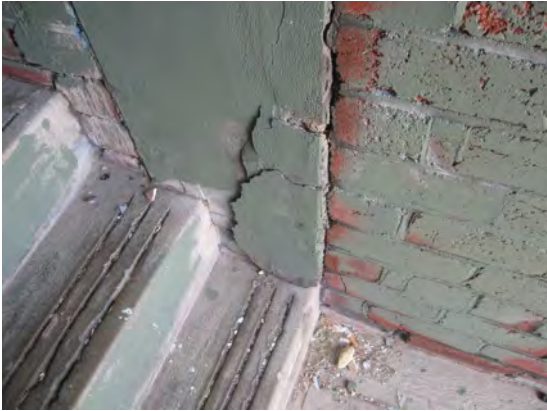
Render to concrete column at foot of stairs is drummy, cracking and falling off.

Painted finish with graffiti	Remove drummy render from the concrete column at the foot of the stairs, ensuring that all retained render is in a sound condition. Patch repair in a render mix to match existing.  If the structure is to be secured by the metal grille gate graffiti should not be an ongoing issue for the internal space and once all paint and graffiti has been removed, there should not be a requirement to coat the internal fabric with an anti-graffiti coating.	2

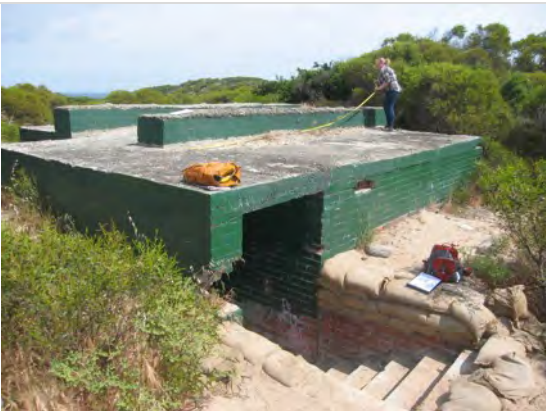
North Elevation	D	<p>Upper sections of brick walls are showing signs of failure due to water damage from the flat roof causing the steel reinforcement bars to rust and expand causing failure to the brickwork. The north west corner has experienced brick loss as a result.</p>	<p>The reinforcing bars should be removed to prevent further damage. Each should be cut out by raking out the joints, removing the corroded steel, replace with Helibars to crack stitch the walls to engineer specifications.</p> <p>Areas of damaged mortar to be raked out to an appropriate depth to allow the new mortar to hold. New mortar is to match the existing and is advisable to have the mortar analysed to ensure a match is made. The mortar is likely to be a lime mortar which is softer than the brick allowing for moisture to escape through the joints rather than destroy the brick. Due to the harsh environmental conditions the structures are located in, consideration may be</p>	<p>1</p> <p>1</p>

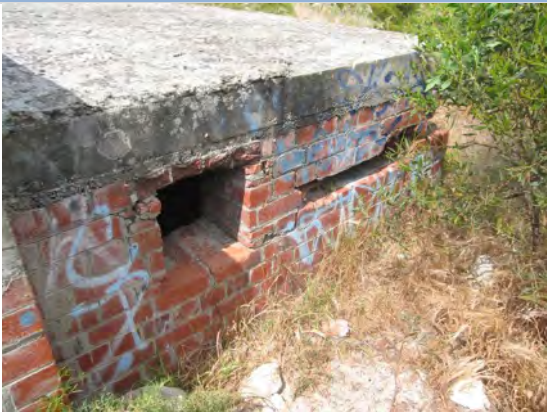
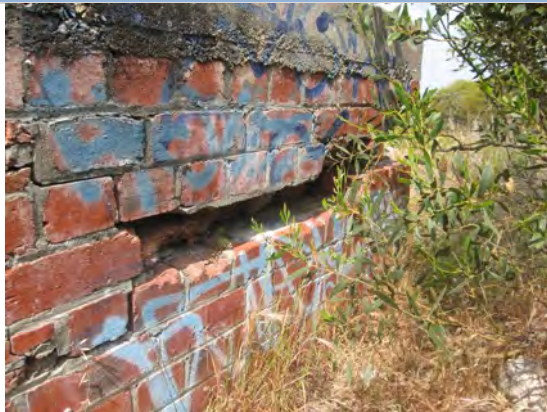
<p>The concrete roof slab in the north east corner has been pushed up from the brickwork with the corner of the slab breaking off.</p>	<p>given to using a hydraulic lime to give increased strength. The original style of pointing should be replicated in all new work.</p> <p>Where bricks need to be replaced, these should be salvaged bricks to match the existing. Bricks from around the site may be used. All introduced bricks should be the same dimensions as the originals.</p> <p>Concrete elements are to be remediated. Rusting to the structural elements encased by the concrete is becoming visible causing the concrete to spall and break off. The high salt content in the air contributes to the accelerated rate of deterioration as does inadequate protection from water ingress.</p> <p>It is not recommended that the damaged concrete be removed in its entirety, utilising patch repairs to try and retain the original fabric. Where the steel reinforcement has rusted causing the concrete to spall, the concrete needs to be cutback and the steel cleaned, treated with an anticorrosive treatment such as Sika Ferro Guard and new concrete patched in to match existing. Due to the harsh environmental conditions at Point Peron, it is recommended that a corrosion barrier coating is applied to all concrete surfaces to reduce/delay further deterioration.</p> <p>Graffiti is an issue across the site. Santi graffiti coatings can be applied but these should not be to the detriment of the original underlying fabric. Any coating should allow the underlying fabric to breathe and function as designed. Any coating should not impact on the aesthetic of the underlying fabric.</p>	1

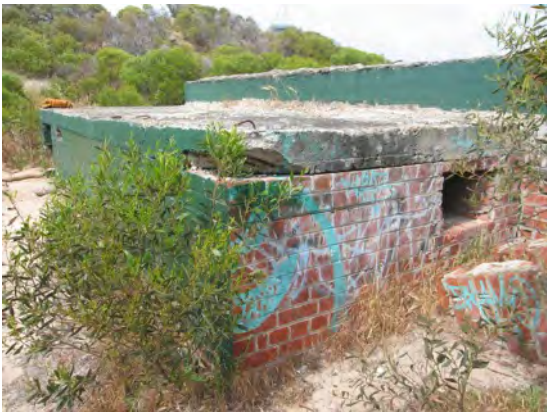
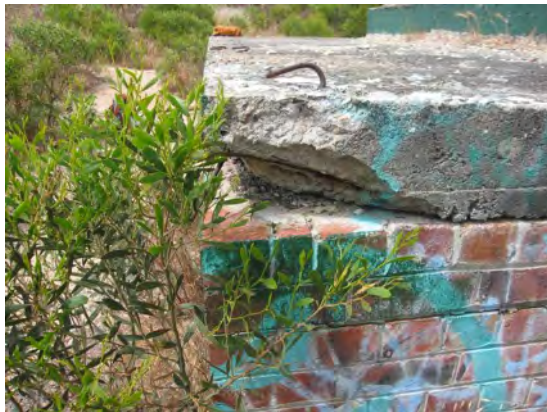
<p>The brickwork around the two small openings is damaged and the flue shafts that once protected the openings have become detached from the main structure due to not being keyed in.</p>		1

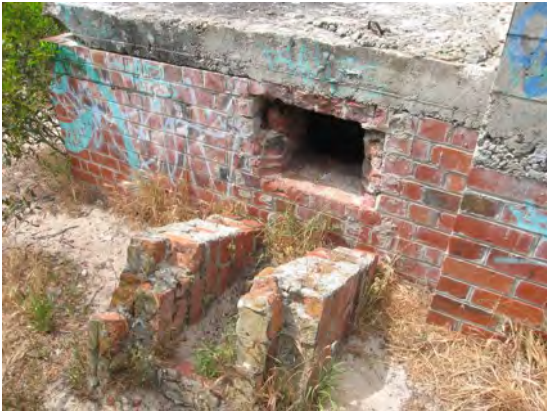
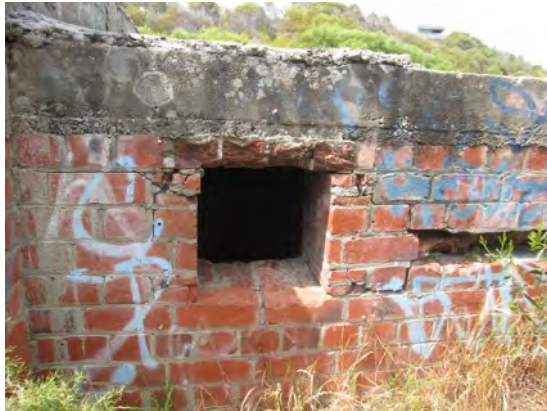
<p>Brickwork is covered in graffiti</p>		
East Elevation	B	The east elevation incorporates the entrance and is generally in good condition. Bricks are missing to the south east corner by the entrance and along the main elevation.	Remove paint from entire elevation as this can contribute to the deterioration of the fabric. Paint removal should not unduly damage the substrate and mortar and test panels in discrete locations should be established prior to embarking on the full removal. Non-caustic solvent based methods or low pressure steam removal can be tried. Peelaway paint removal system can be used or Westox’s DeLam which	2

<p>applies a poultice to the paint and will be ready to be removed within a few days. Not all paint traces will be removed due to the texture of the bricks and concrete. Specifier's instructions are to be followed in the application.</p> <p>The missing brickwork around the entrance should be reinstated. Check around the structure to look for bricks. If salvaged bricks are to be used, ensure they are clean of mortar debris prior to reinstatement. Rake the mortar joints out to a good depth to ensure the new mortar will hold and relay the bricks using the same bond and pointing style as the original.</p>	1
South Elevation	B	<p>Upper sections of brick walls are showing signs of failure due to water damage from the flat roof causing the steel reinforcement bars to rust and expand causing failure to the brickwork.</p>

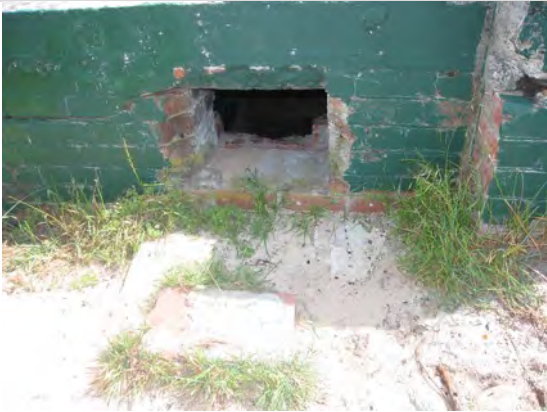
West Elevation	D	Upper sections of brick walls are showing signs of failure due to water damage from the flat roof causing the steel reinforcement bars to rust and expand causing failure to the brickwork.	The reinforcing bars should be removed to prevent further damage. Each should be cut out by raking out the joints, removing the corroded steel, replace with Helibars to crack stitch the walls to engineer specifications.	1

Areas of damaged mortar to be raked out to an appropriate depth to allow the new mortar to hold. New mortar is to match the existing and is advisable to have the mortar analysed to ensure a match is made. The mortar is likely to be a lime mortar which is softer than the brick allowing for moisture to escape through the joints rather than destroy the brick. Due to the harsh environmental conditions the structures are located in, consideration may be given to using a hydraulic lime to give increased strength. The original style of pointing should be replicated in all new work.	1

Where bricks need to be replaced, these should be salvaged bricks to match the existing. Bricks from around the site may be used. All introduced bricks should be the same dimensions as the originals.	1

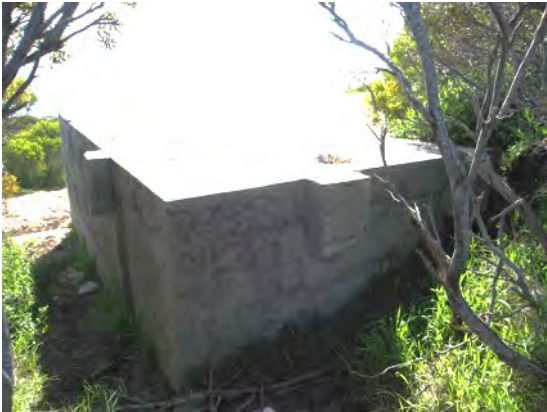
Building Name	Condition Rating	Defect and Location	Work to Rectify Defect	Priority Ranking
		 	Monitor the rate of deterioration to the air vents. The undersides have corroded due to water ingress and will require remedial action in the future to prevent the entire element being lost. The method of patch repairs outlined above can be utilised.	2
East Elevation		The east elevation is obscured by sand dune and vegetation. It is unpainted and is likely to be in good condition.	Full inspection of the elevation is required to determine condition. Small scale concrete patch repairs re likely.	1
South Elevation	B	Partially submerged into sand dune and partially obscured by vegetation. Full inspection not possible. Concrete deterioration to base of air vent shaft.

Full inspection of the elevation is required to determine condition.  Concrete patch repairs required to base of air vent shaft.	1  2

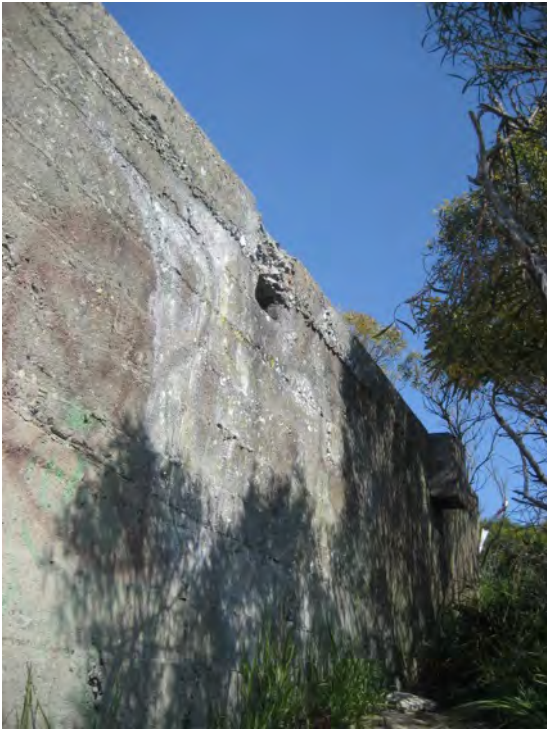
Building Name	Condition Rating	Defect and Location	Work to Rectify Defect	Priority Ranking
West Elevation	C	<p>Slight concrete damage. Loss of ventilation shaft and deterioration to underlying concrete. Water drainage issues from roof causing some of the deterioration.</p>

<p>Repair concrete around the air vent. To prevent further damage the air vent shaft should be reconstructed based on the design of extant air shafts. Protection of the opening will safeguard the vulnerable fabric around the opening and also prevent water ingress into the building.</p>	2
Roof	C	<p>Appears to be in sound condition with only hairline cracking. Water drainage issues causing some damage to the air vent shafts and edge of the concrete roof. Sand build up on the roof with subsequent vegetation growth.</p>

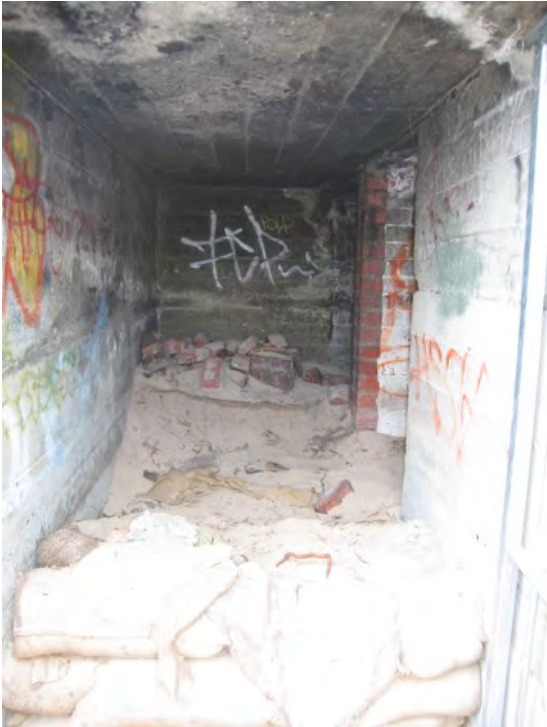
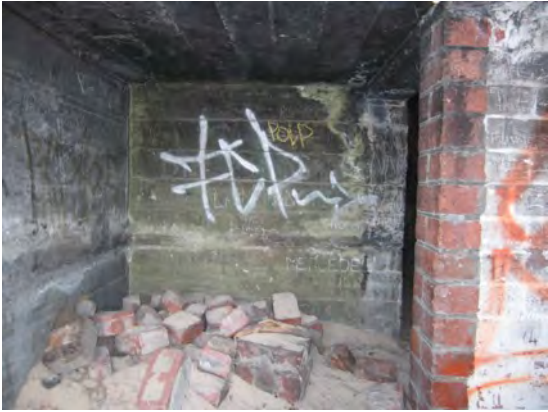
Building Name	Condition Rating	Defect and Location	Work to Rectify Defect	Priority Ranking
Interior				
Entry passageway	C	<div>Concrete walls, ceiling and floor. Graffiti to most surfaces. Deep sand build-up. Partial painted treatment to walls.</div> <div>

</div>	<div>Remove paint from entire elevation as this can contribute to the deterioration of the fabric. Paint removal should not unduly damage the substrate and mortar and test panels in discrete locations should be established prior to embarking on the full removal. Non-caustic solvent based methods or low pressure steam removal can be tried. Peelaway paint removal system can be used or Westox's DeLam which applies a poultice to the paint and will be ready to be removed within a few days. Not all paint traces will be removed due to the texture of the bricks and concrete.</div> <div>Remove sand and inspect walls and floor for damage.</div> <div>Retain all loose bricks for repairs to the structure or other buildings on site.</div>	<div>2</div> <div>1</div>

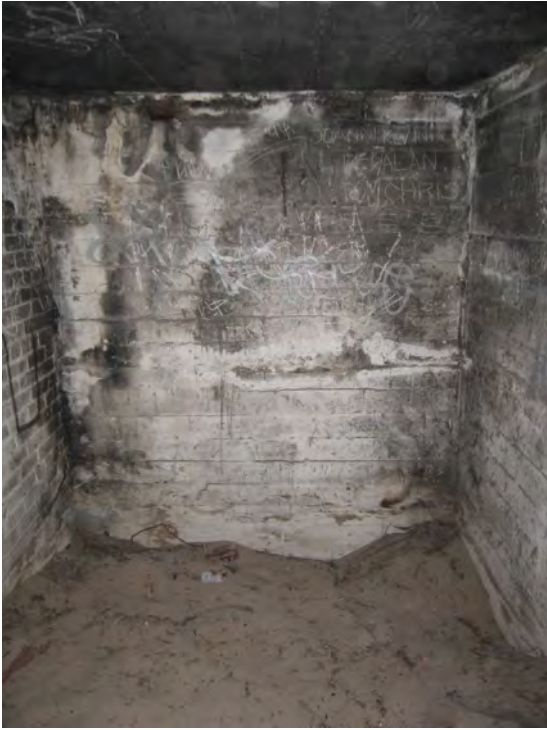
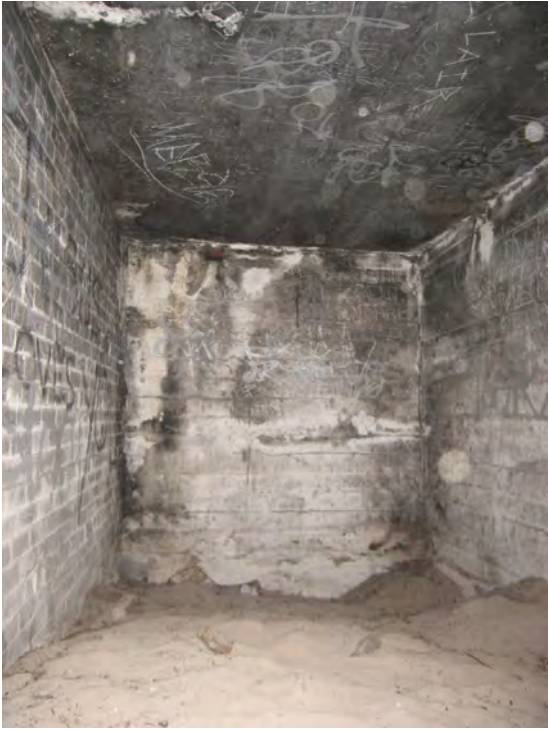
Room 1	C	<div>Concrete outer walls and a brick partition wall. Clouded white paint finish wearing off. Walls with graffiti. Sand accumulation.</div> <div>

</div>	<div>Remove sand accumulation and monitor further collections to prevent damage to floor and lower levels of the walls. Remove painted finish and graffiti.</div>	<div>2</div>

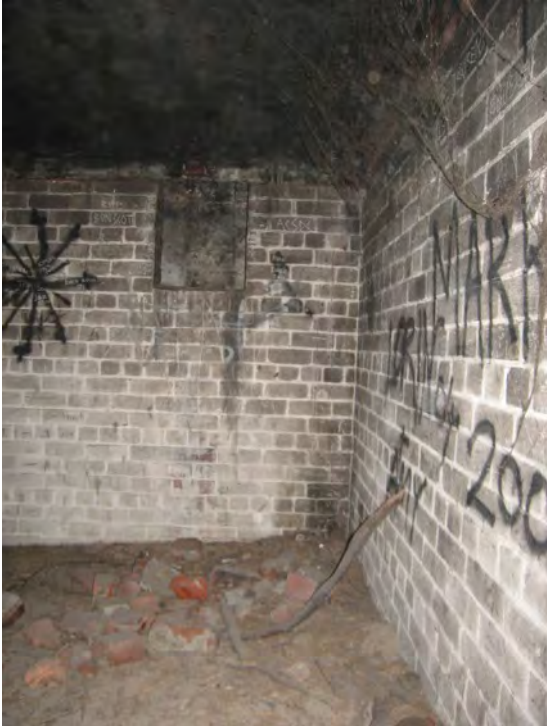
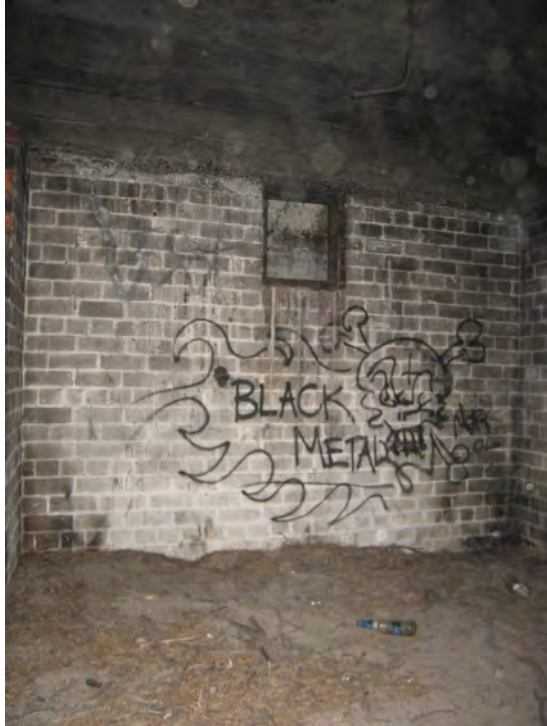
Building Name	Condition Rating	Defect and Location	Work to Rectify Defect	Priority Ranking
Room 2 plus blast corridor	C	<p>Brick internal walls with concrete outer walls. Clouded paint finish to walls with graffiti. Sand accumulation.</p> <div>

</div>	<p>Remove graffiti. There is no requirement for an anti-graffiti coating to be applied if public access is going to be controlled. Removal of graffiti should not damage the underlying brick and concrete.</p> <p>Remove painted finish to the walls as per specifications above or other suitable alternative conservation method.</p> <p>Slight signs of concrete deterioration to the ceiling. Further deterioration to be monitored.</p> <p>Sand accumulation to be monitored and removed prior to substantial build-up.</p>	<p>2</p> <p>2</p>
<p><b>Gun Emplacement No. 2</b></p> <p>Reinforced concrete retaining wall, brick steps and paving, central reinforced concrete gun mount</p>	B	<p>Gun Emplacement No. 2 is in good condition and has not suffered from the same fate as its counterpart Gun Emplacement No. 1. Shifting sand and ground conditions do not appear to be impacting on the structural condition of this structure.</p> <p>There is some concrete damage to the top of the gun mount and the steel perimeter edging around the top of the mount has rusted in places, springing loose from the concrete it is encasing.</p> <p>Sand accumulation in places.</p> <p>Non-original painted surfaces.</p> <div>

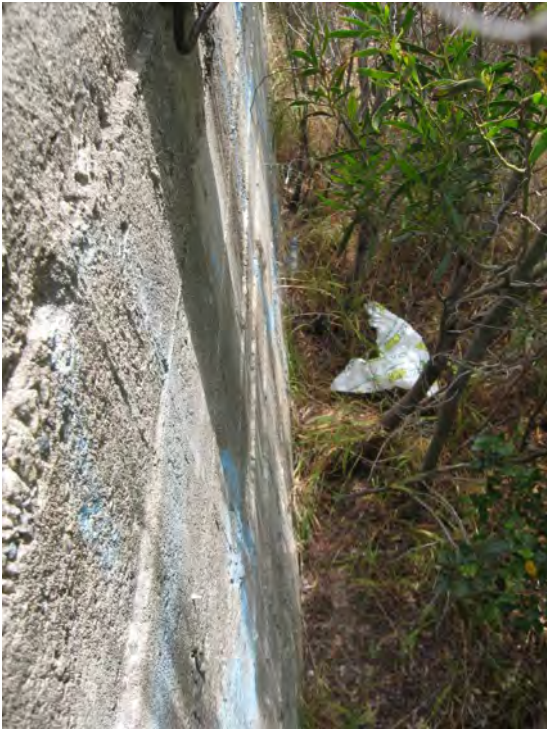
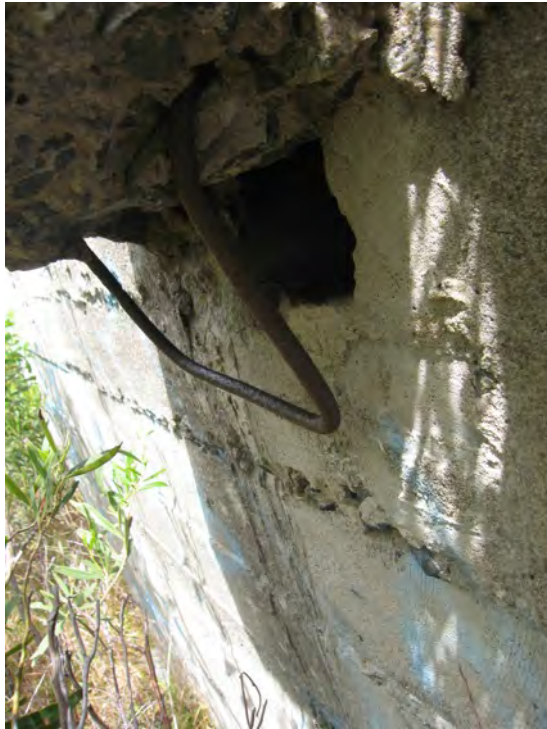
North Elevation	C	Mainly obscured by vegetation and steep drop in the land form. Unpainted concrete construction with some graffiti. The visible sections of the elevation generally appear to be in sound condition but the projecting air vent shafts have succumbed to concrete cancer with the bottom sections completely eroding in places, revealing the reinforcing steels.

A full inspection of the north elevation is required to accurately determine its condition. From the limited access available the main elevation appears in sound condition with deterioration being limited to the base of the air vent shafts. This is caused by water run off from the roof and proximity to the surrounding vegetation. Some of the vegetation may need to be cleared to reduce impacts on the fabric of the building. The steels need to be cleaned and treated with an anti-corrosive treatment prior to the concrete being reapplied. The concrete may then be coated with a barrier to reduce the amount of water ingress and subsequent deterioration.	2

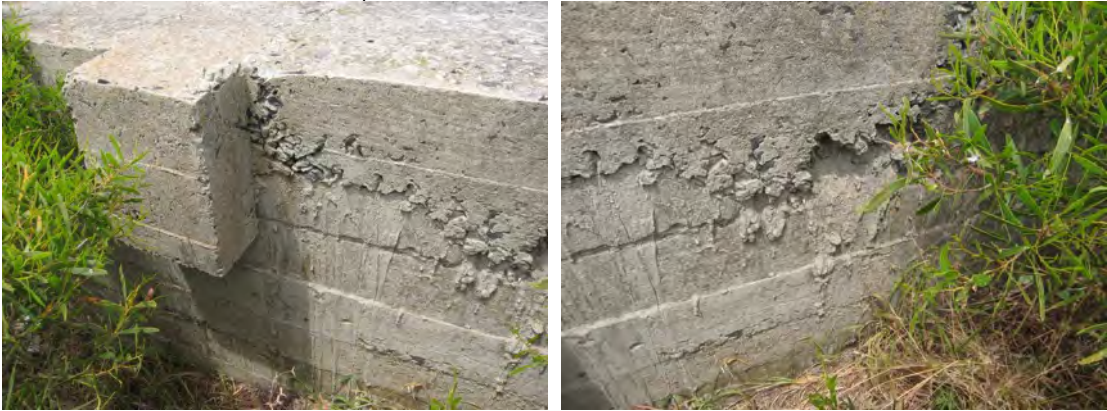
Building Name	Condition Rating	Defect and Location	Work to Rectify Defect	Priority Ranking
West Elevation		<p>Much of the west elevation is obscured by vegetation. The elevation is partially submerged. Projecting air shafts extending from the roof level down approximately three block courses. The underside of the vents showing signs of concrete cancer and erosion in some instances.</p> <p>This elevation has not been painted.</p>

<p>Full inspection of elevation is required to determine condition. This may require the removal of some vegetation.</p> <p>Monitor condition of elevation. Patch repairs to the air shaft vents to reduce further deterioration.</p>	<p>1</p> <p>3</p>
Roof	C	<p>Slight cracking , especially at the edges of the roof, resulting in water ingress into the interior. If left unchecked this will result in eventual concrete cancer.</p> <p>Generally in good condition.</p>

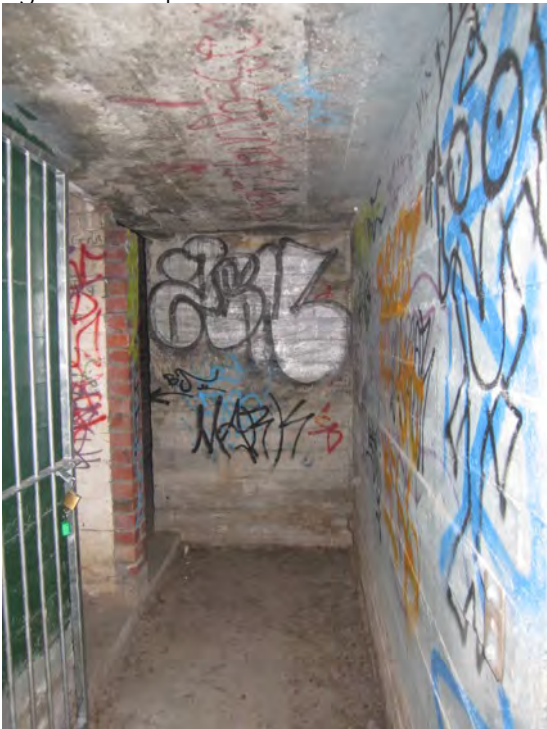
Building Name	Condition Rating	Defect and Location	Work to Rectify Defect	Priority Ranking
Interior				
Entry Passage	C	<p>Concrete walls and ceiling painted in a white paint finish which is beginning to show signs of wear. Walls and ceiling subjected to graffiti. Sand accumulation causing early signs of damp at low level.</p>

<p>Remove paint from entire elevation as this can contribute to the deterioration of the fabric. Paint removal should not unduly damage the substrate and mortar and test panels in discrete locations should be established prior to embarking on the full removal. Non-caustic solvent based methods or low pressure steam removal can be tried.</p> <p>Peelaway paint removal system can be used or Westox’s DeLam which applies a poultice to the paint and will be ready to be removed within a few days. Not all paint traces will be removed due to the texture of the bricks and concrete.</p> <p>Graffiti to be removed. An anti-graffiti coating is not required.</p> <p>Ensure sand levels are maintained implementing regular removal.</p>	3

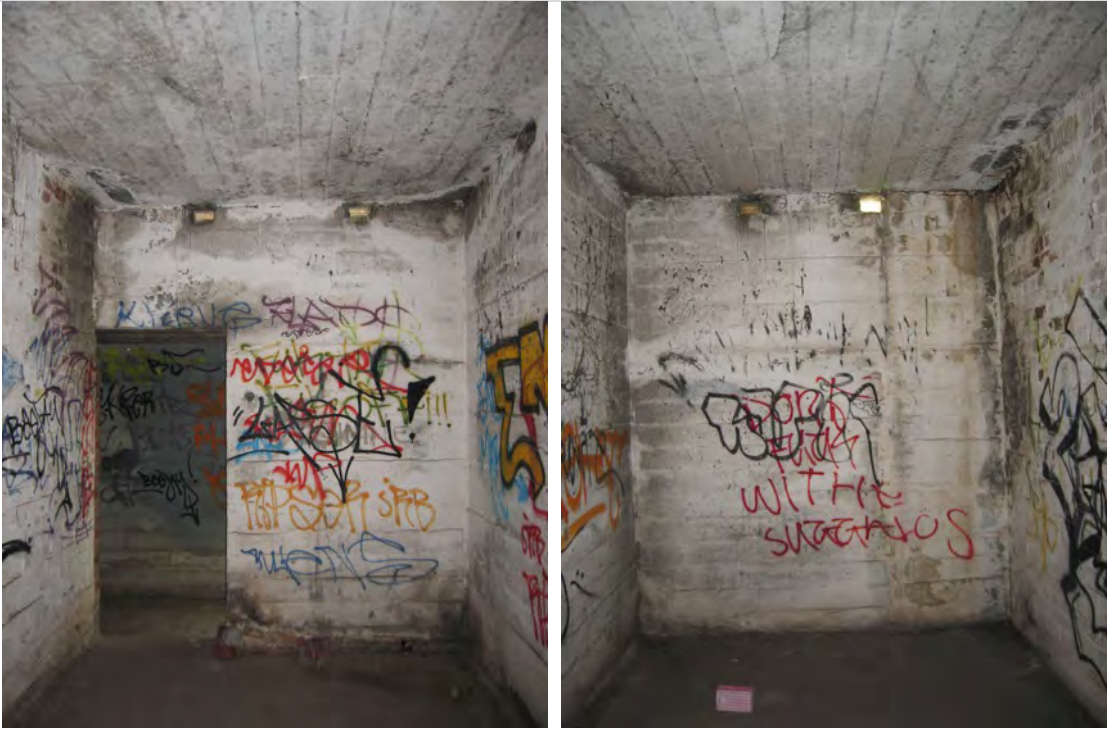
Room 2 plus blast corridor	C	<p>Brick work to the internal walls is generally in sound condition, with some graffiti. Dusted white painted finish wearing off from the walls. Some slight signs of damp at the junction between the wall and ceiling, likely to be in line with the roof cracks. Evidence of recent sand removal from both the main room and the blast corridor.</p> <p>Signs of early concrete cancer to the roof with some of the enforcement bars rusting and breaking through the concrete.</p>	<p>Remove paint from entire elevation as this can contribute to the deterioration of the fabric. Paint removal should not unduly damage the substrate and mortar and test panels in discrete locations should be established prior to embarking on the full removal. Non-caustic solvent based methods or low pressure steam removal can be tried.</p> <p>Peelaway paint removal system can be used or Westox's DeLam which applies a poultice to the paint and will be ready to be removed within a few days. Not all paint traces will be removed due to the texture of the bricks and concrete.</p> <p>Remove graffiti. An anti-graffiti coating is not required.</p> <p>Ensure sand levels are monitored, removing any sand build up on a regular basis.</p>	<p>2</p> <p>2</p> <p>1</p>
