# Point Peron "K" Battery Conservation Management Plan

South West Corridor Development Foundation Inc.

March 2016

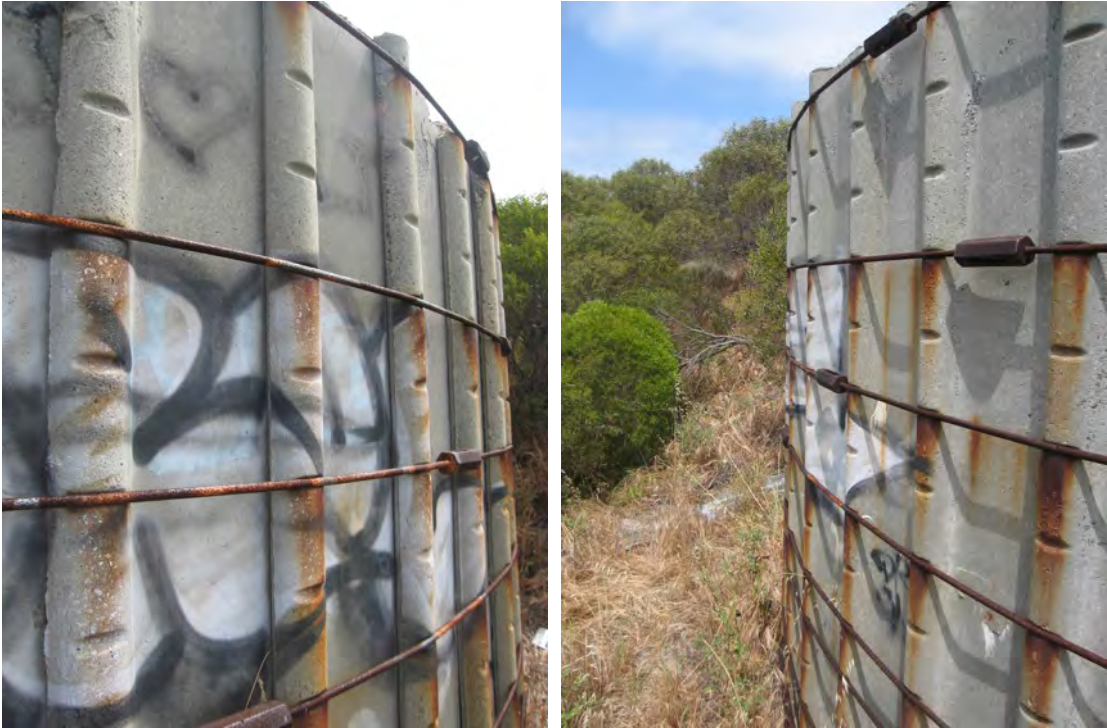
<b>Water Tank</b>  Reinforced concrete, corrugated iron roof no longer extant but possible remnant roofing material lays in and around the tank	C	<p>Slight signs of concrete cancer, rusted steel tension bands and substantial graffiti to the interior. Roof no longer extant but remnant fabric may exist in the foot of the tank and around the structure.</p>

<p>Retention or removal is a decision for the owners of the site. Concrete cancer is beginning to occur which will require remediation if the structure is to be retained for interpretation purposes.</p> <p>There is no requirement to reinstate the corrugated iron roof.</p> <p>Removal of graffiti from the interior of the tank is recommended and consideration should be given to coating the structure with an anti-graffiti coating ensuring that this does not cause harm to the underlying fabric.</p>	2

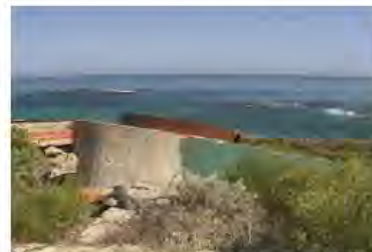
PHOTO: The coastal defence battery at Point Peron has fallen into disrepair. (ABC News)
